# PACE-2023

The Second International Congress on the  
Phenomenological Aspects of Civil Engineering

Transactions  
of  
The Second  
International Congress  
on the  
Phenomenological Aspects  
of  
Civil Engineering

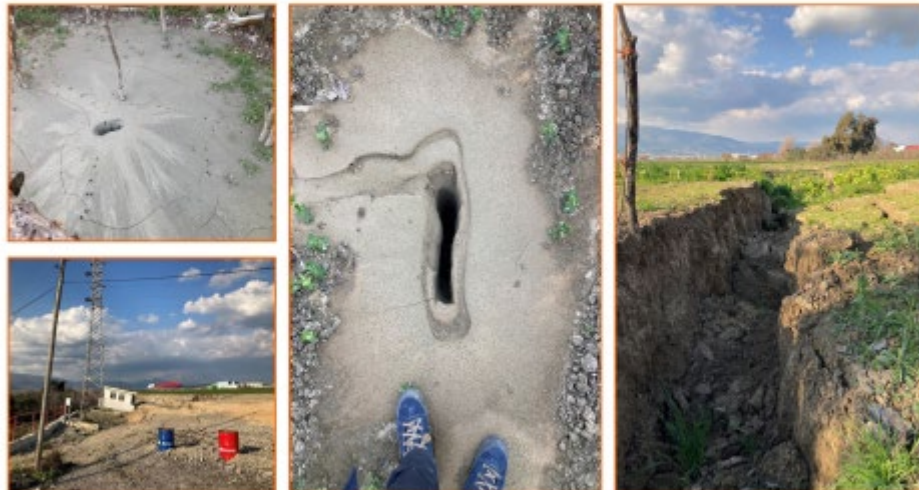
Earthquake-triggered liquefaction phenomena and subsidence reported from the northeastern end of the Hatay city center. Source: [https://twitter.com/geodesist\\_a/status/1624410147853414400](https://twitter.com/geodesist_a/status/1624410147853414400)

- Soil liquefaction occurs when a saturated or partially saturated soil lacking cohesion substantially loses strength and stiffness in response to earthquake ground motion.
- In other words, soil behaves like a liquid.
- Liquefaction that occurs beneath buildings and other structures can cause major damage leading to severely tilted buildings, ground subsidence and lateral flow of soil during strong earthquakes.

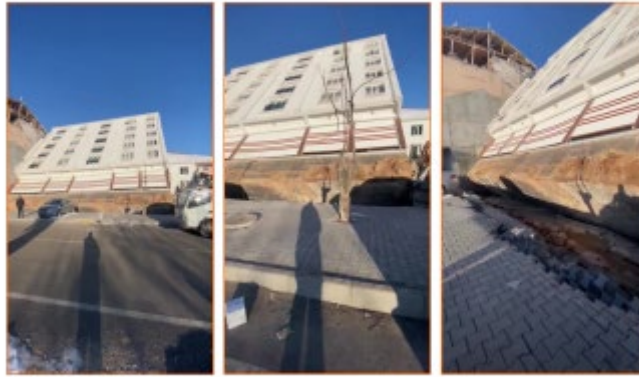
Liquefaction phenomena resulted in tilting of a building with no damage in the upper floors.  
Source: <https://twitter.com/aysekarahassan/status/1623767921758461953>

- Soil conditions induced seismic demands caused heavily damage and collapse
- Insufficient foundations
- Overturning of buildings due to bearing-capacity failure on soft soil under strong seismic moment.
- In regions such as Hatay-Antakya and Adıyaman-Gölbasi, buildings collapsed due to soil liquefaction, either by sinking into the ground or tilting to the side entirely or partially sinking into the liquefied ground obliquely depending on the characteristics of their foundation system.

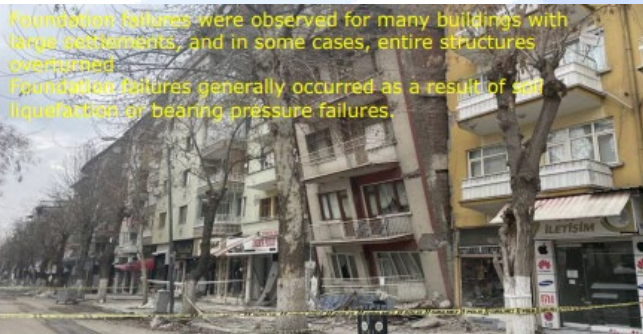
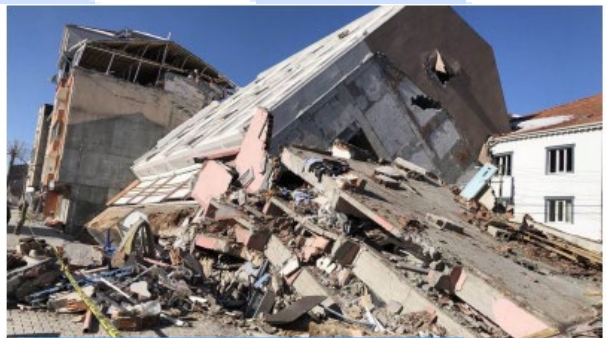
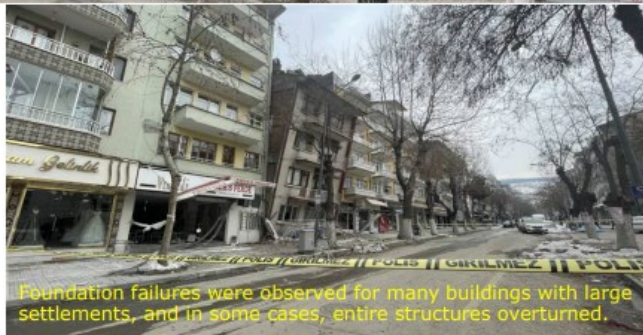
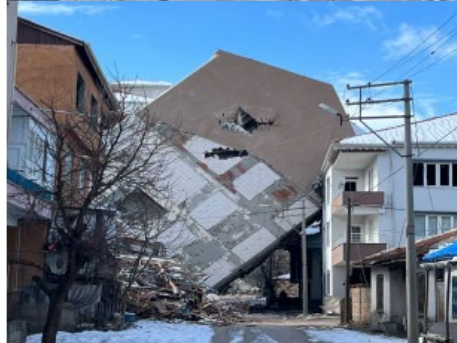
- RC Building with pile foundation - 1.5m settlement

- Liquefaction-induced bearing capacity failures

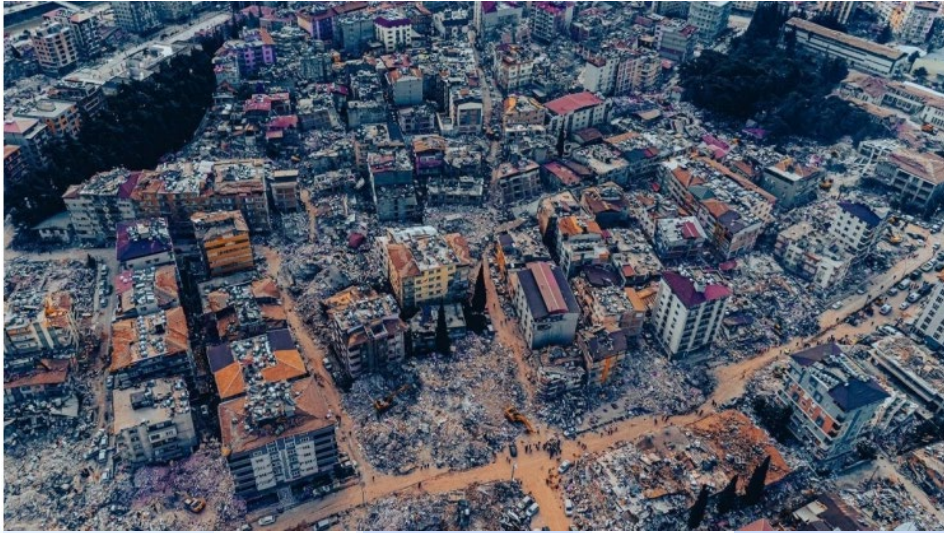
Similar types of damage were observed in many prior earthquakes throughout Turkey.

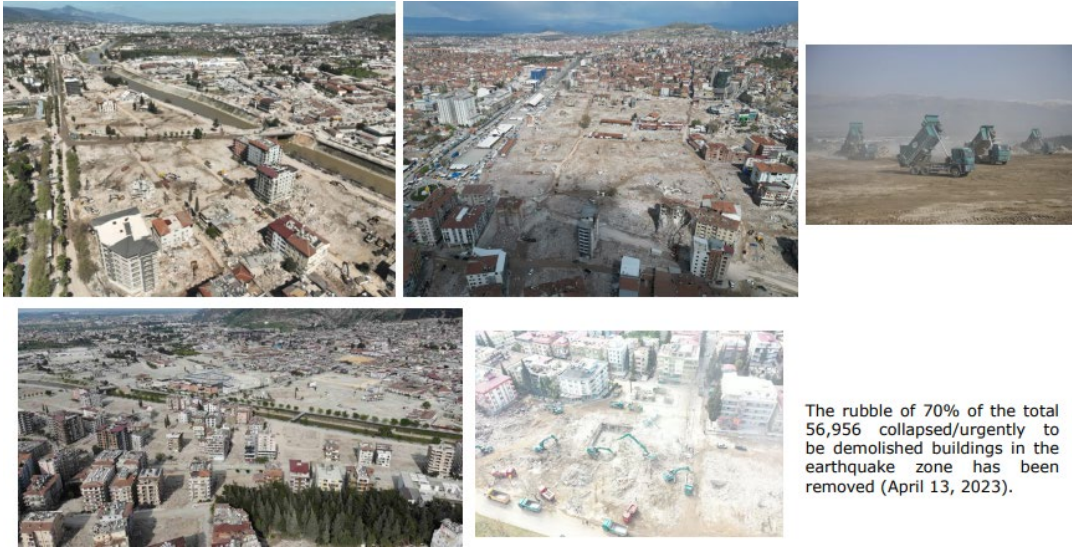
The rubble of 70% of the total 56,956 collapsed/urgently to be demolished buildings in the earthquake zone has been removed (April 13, 2023).

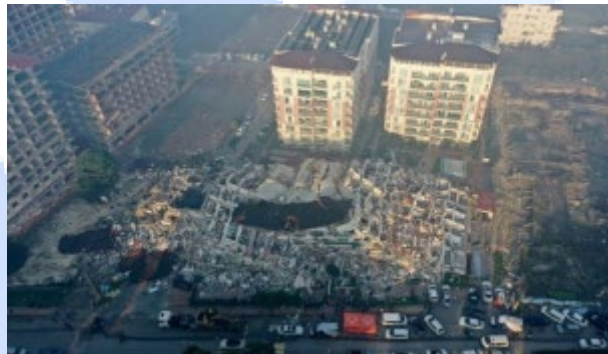
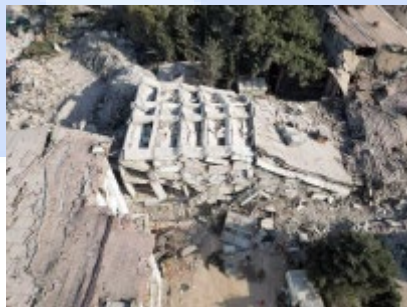
- The majority of collapses occurred within the outline of their floor plans.
- The extensive inelastic action at the critical joints in the RC buildings caused the formation of a hinge at the connection of columns with the beams, thereby creating mechanisms that led to pancake-type collapses, where the floors pile up on each other.

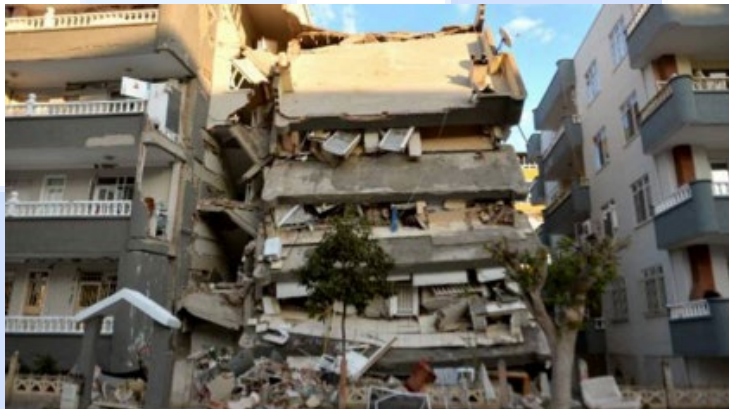
- Some buildings partly collapsed.

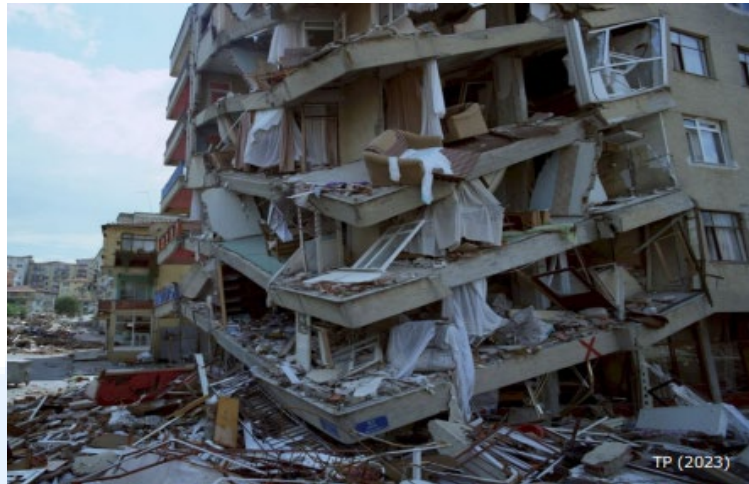
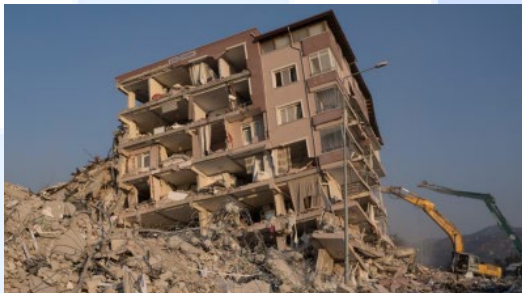
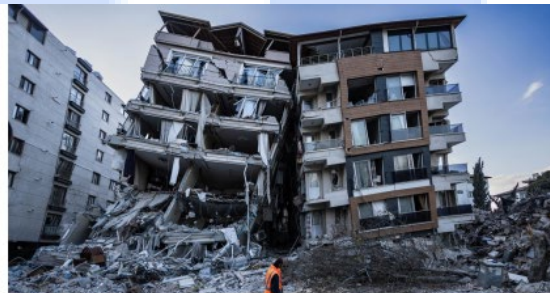
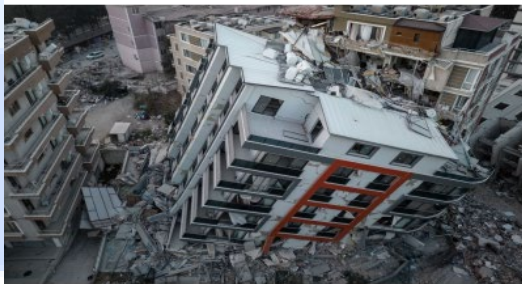
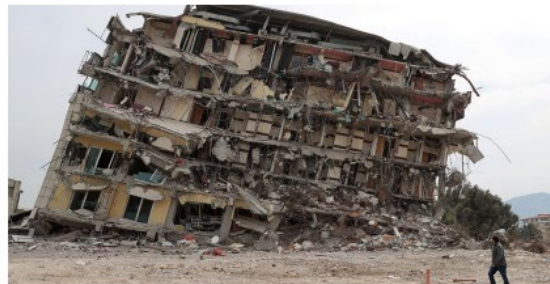
- The collapse of one building among neighboring parcels and buildings with similar sizes, while the other remains standing, could be due to some of the irregularities in one but not the other.
- It should also be considered that there may be differences in ground conditions (thickness of alluvium on the main rock), material and workmanship quality between parcels.

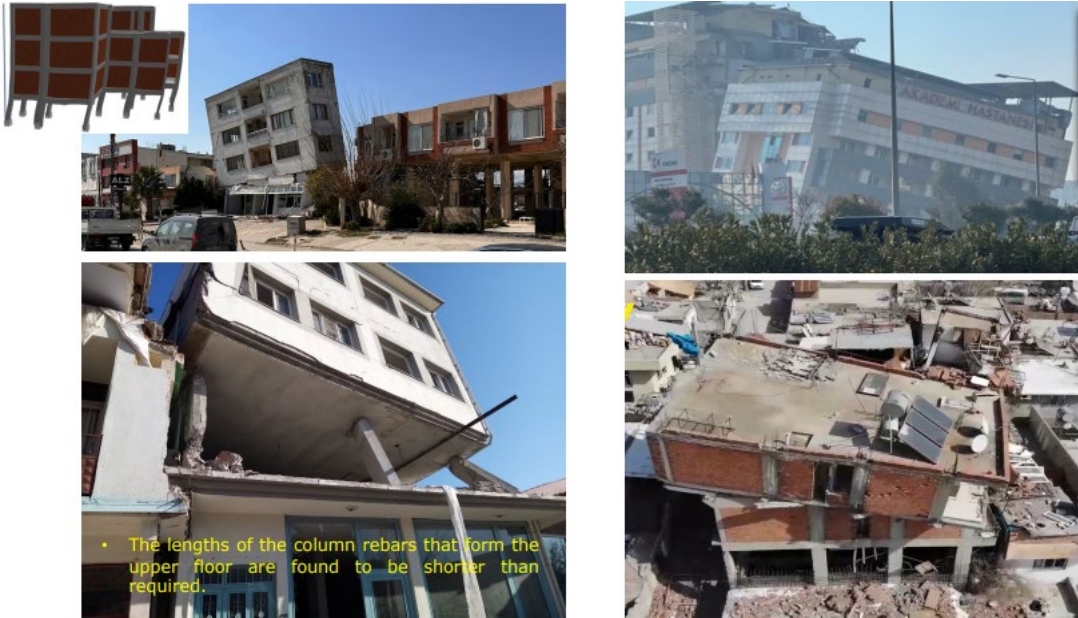
- The lengths of the column rebars that form the upper floor are found to be shorter than required.

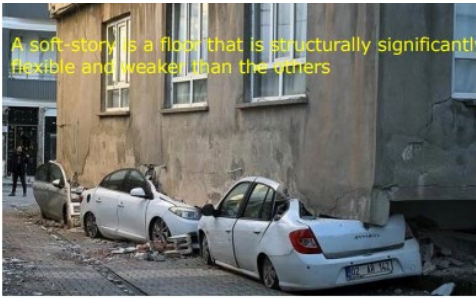
A soft-story is a floor that is structurally significantly more flexible and weaker than the others

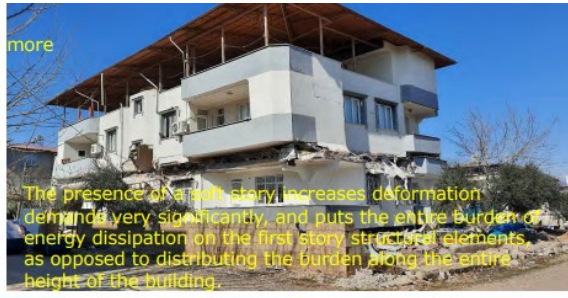
The presence of a soft story increases deformation demands very significantly, and puts the entire burden of energy dissipation on the first story structural elements, as opposed to distributing the burden along the entire height of the building.

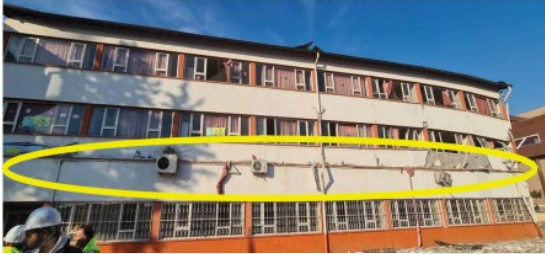
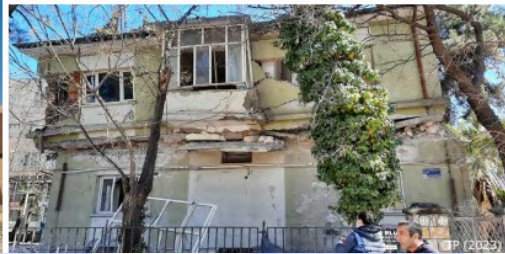
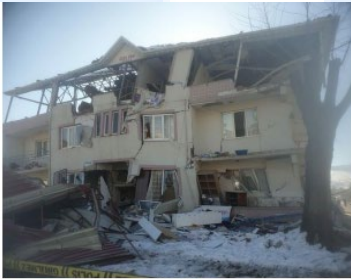
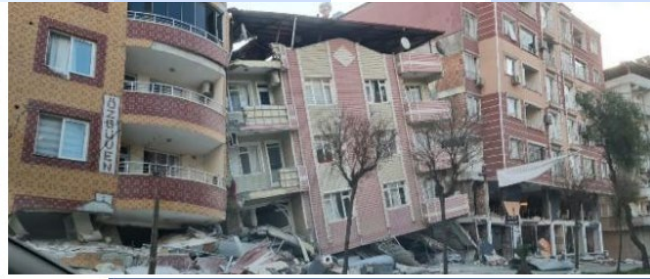
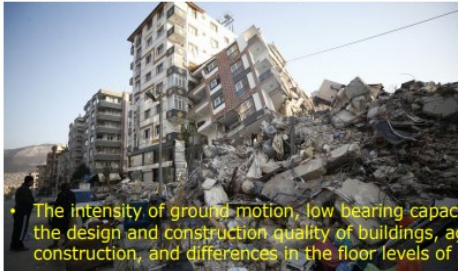
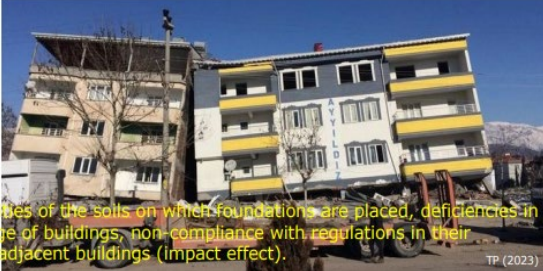
The intensity of ground motion, low bearing capacities of the soils on which foundations are placed, deficiencies in the design and construction quality of buildings, age of buildings, non-compliance with regulations in their construction, and differences in the floor levels of adjacent buildings (Impact effect).

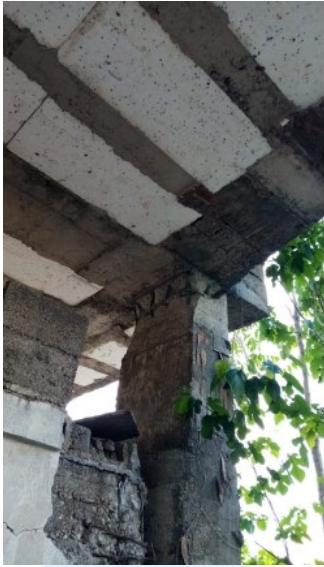
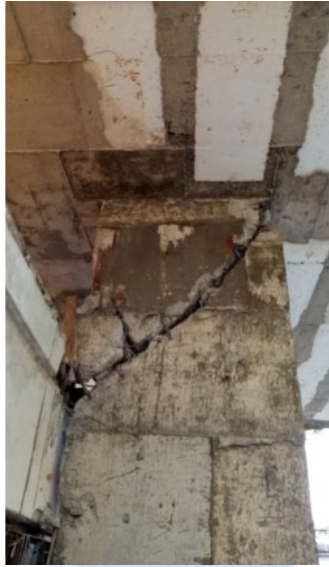
- Insufficeint shear walls, even in >10 story buildings

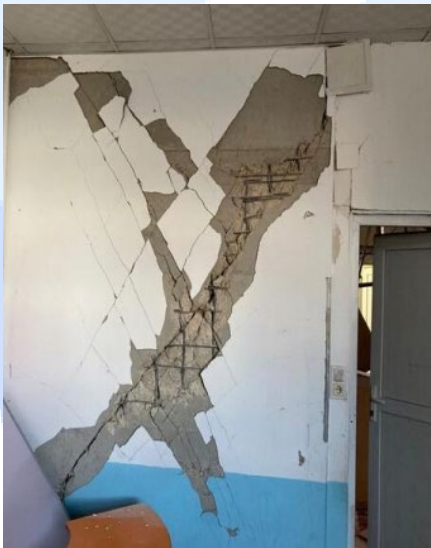
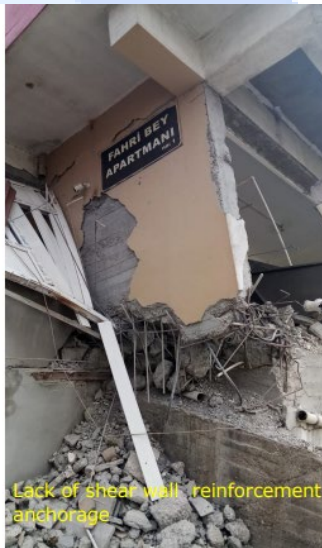
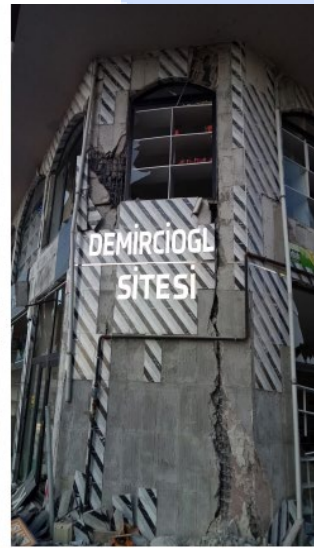
Lack of shear wall reinforcement anchorage

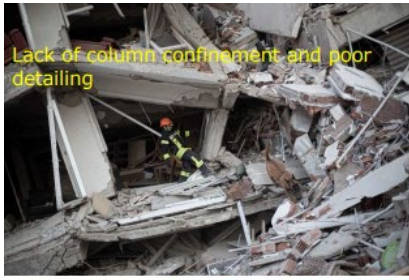
Lack of column confinement and poor detailing

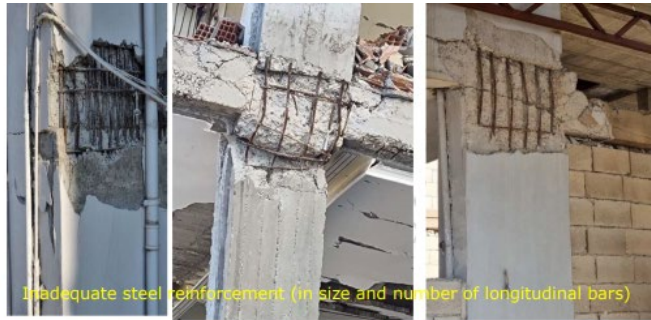
Inadequate steel reinforcement (in size and number of longitudinal bars)

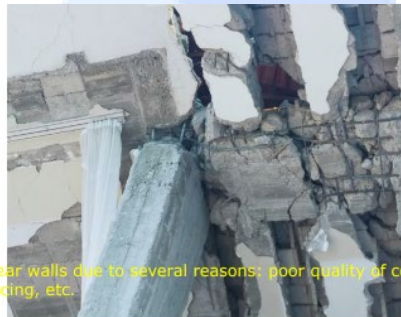
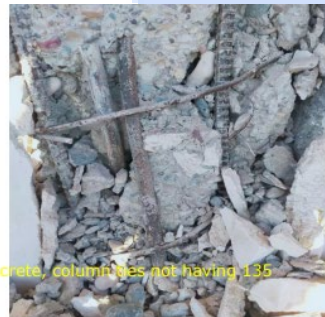
Classical failure of columns and shear walls due to several reasons: poor quality of concrete, columns does not having 135 degree hooks and having large spacing, etc.

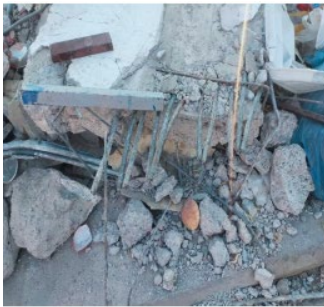
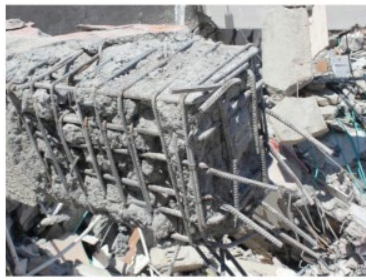
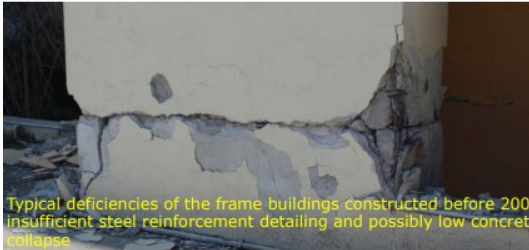
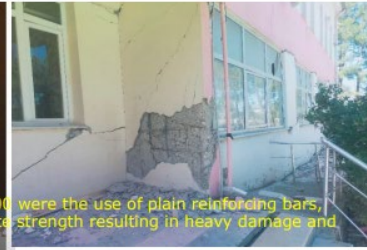
Typical deficiencies of the frame buildings constructed before 2000 were the use of plain reinforcing bars, insufficient steel reinforcement detailing and possibly low concrete strength resulting in heavy damage and collapse

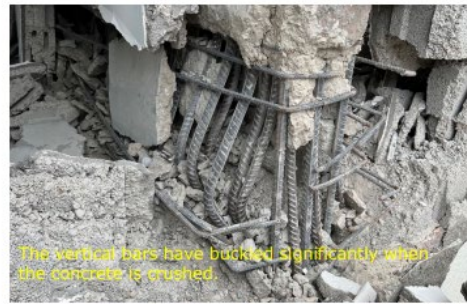
No confinement on both end of the column zone which is very dangerous in earthquake.

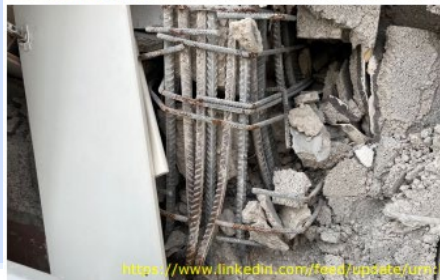
The vertical bars have buckled significantly when the concrete is crushed.

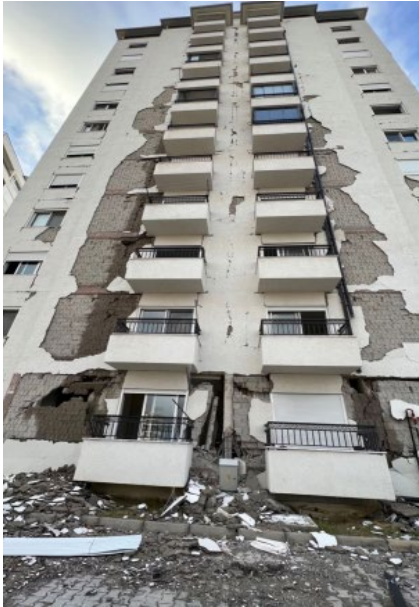
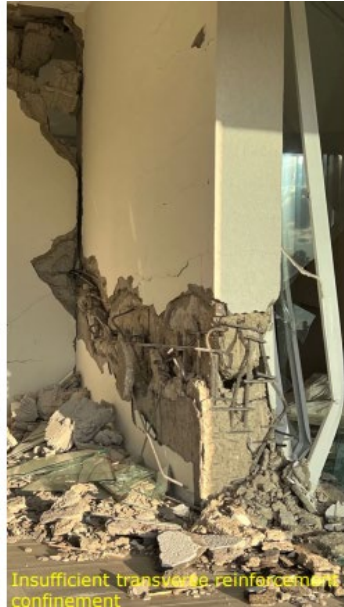
- Necessary reinforcement details were not applied in column-beam connections in collapsing buildings, and that the spacing of stirrups is sparse and stirrup hooks are at right angles.

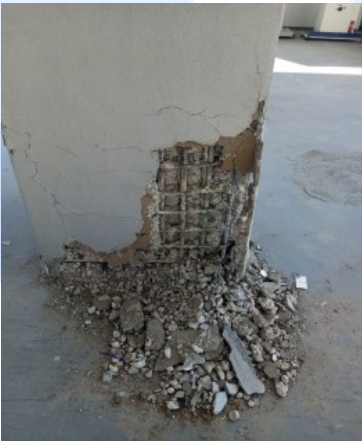
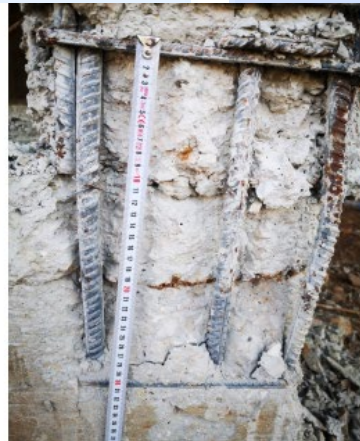
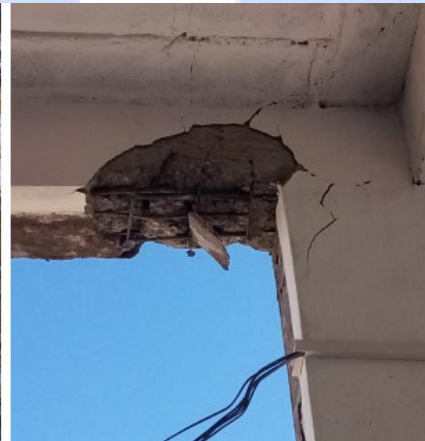
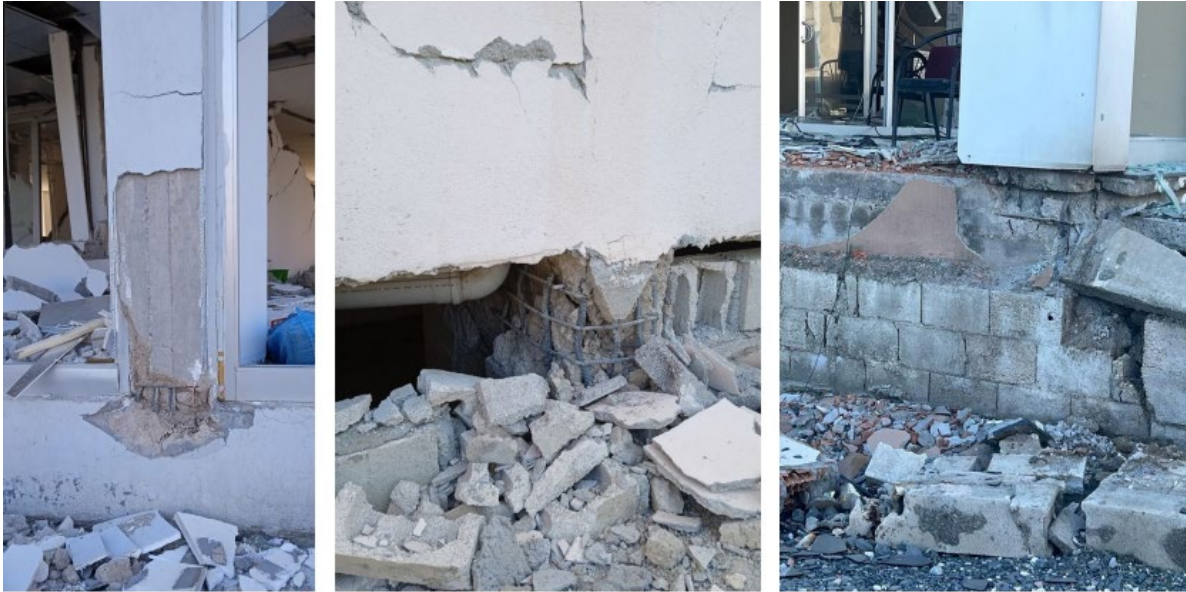
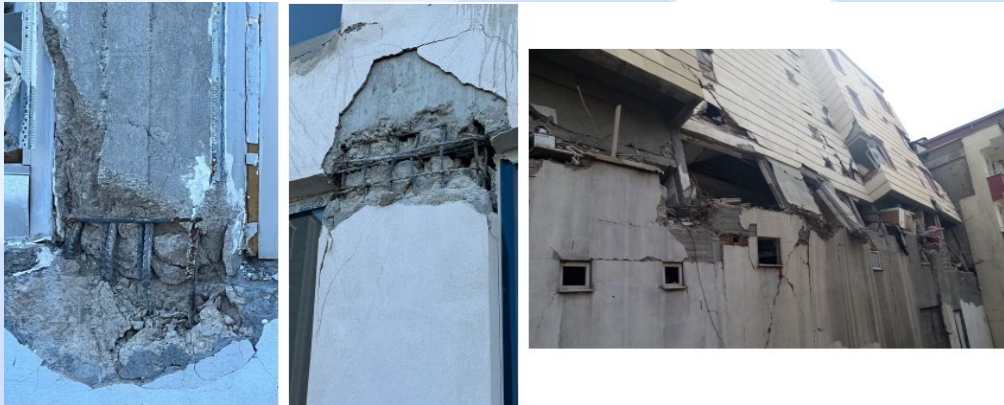
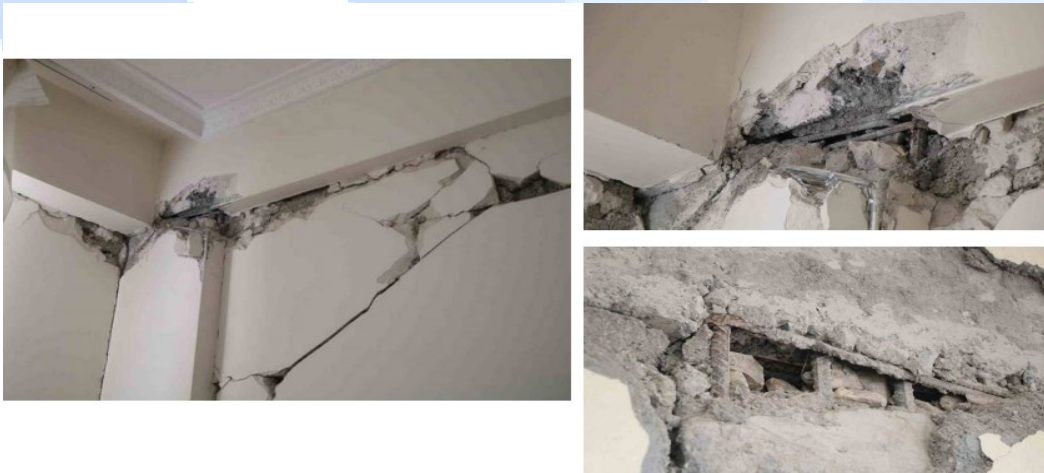
- Many buildings have experienced beam-column joint failures.

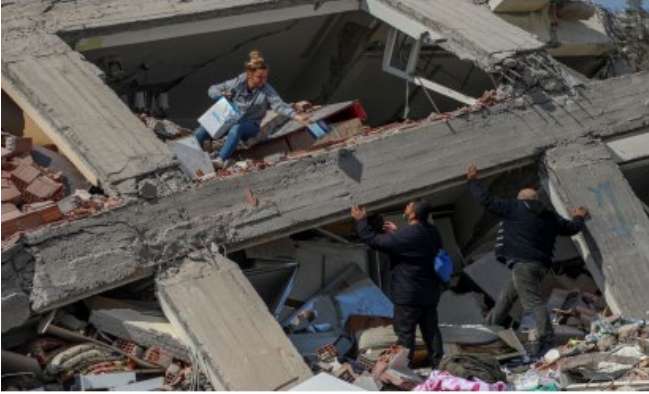
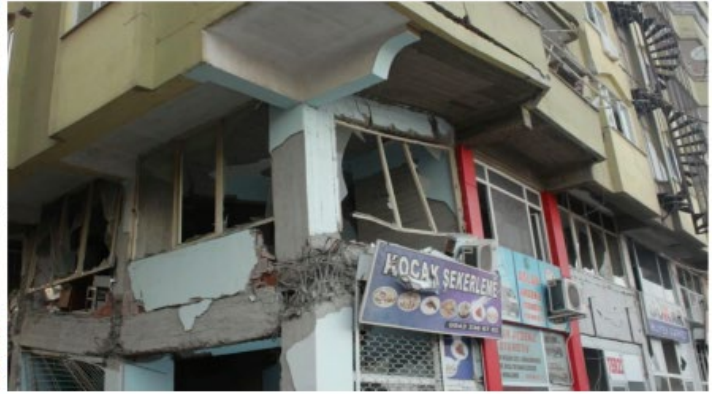
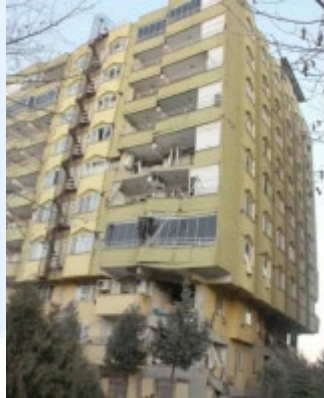
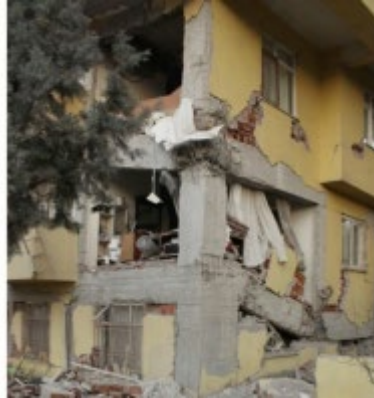
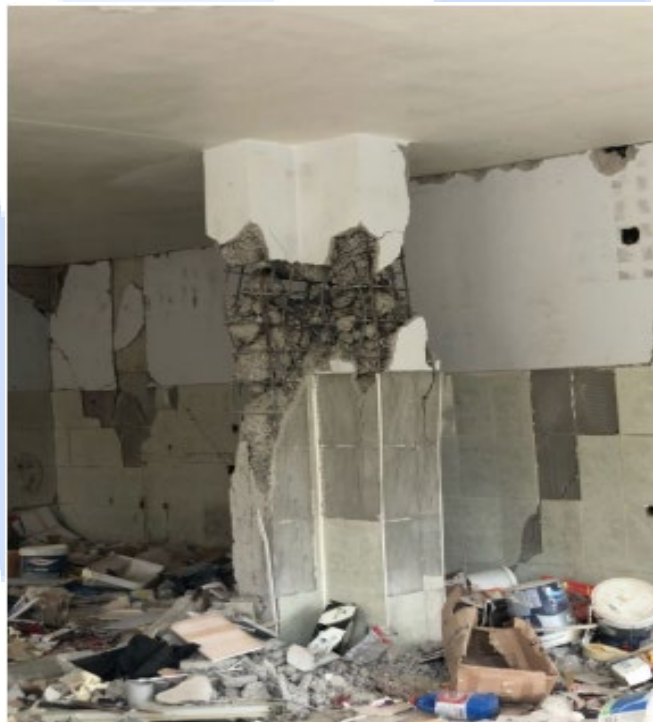
L-shaped central column failure from the ground story of a framed building.

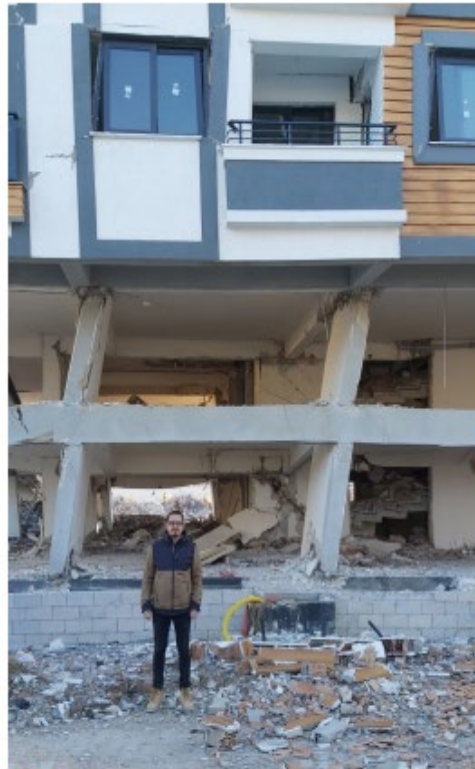
Residual story drift

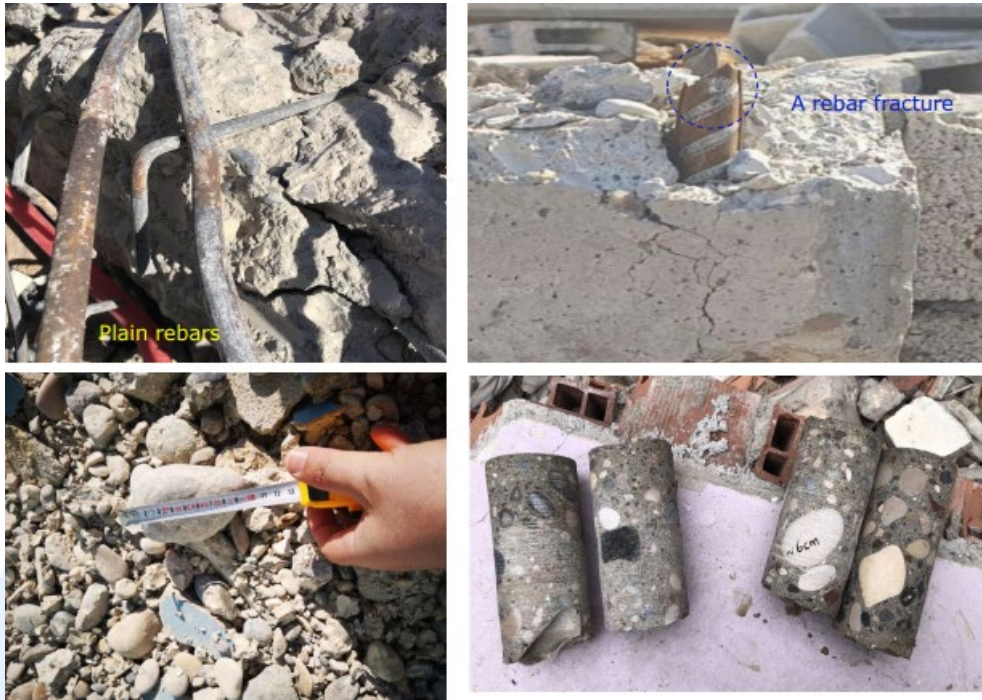
- Low concrete quality and strength. There is a serious weakness in the materials used in both old and new reinforced concrete structures.
- Steel bars smooth instead of ridged.
- Some ridged rebars coming from abroad were fractured.
- Especially for buildings constructed before 2001 when ready-mixed concrete was not yet widely used.

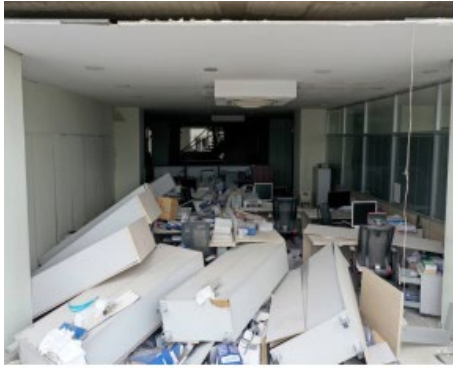
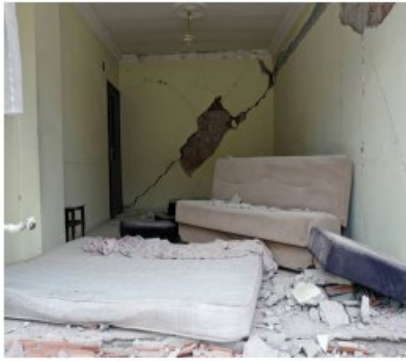
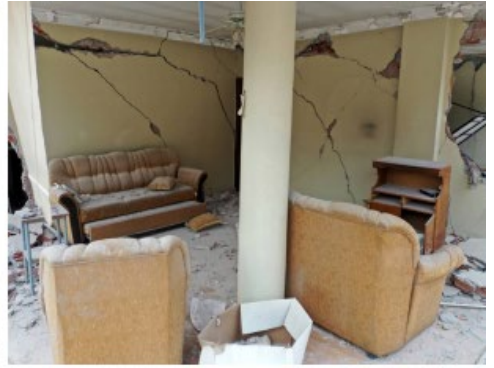
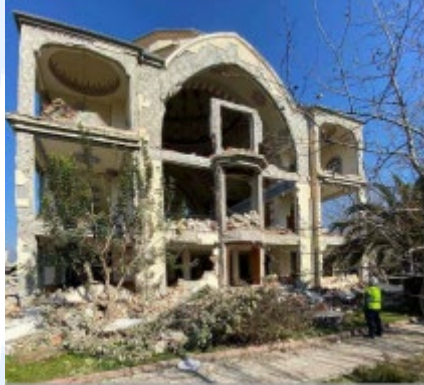
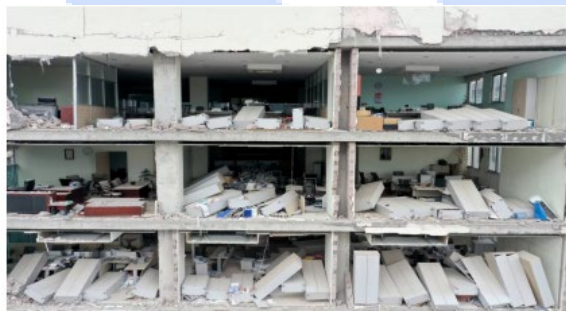
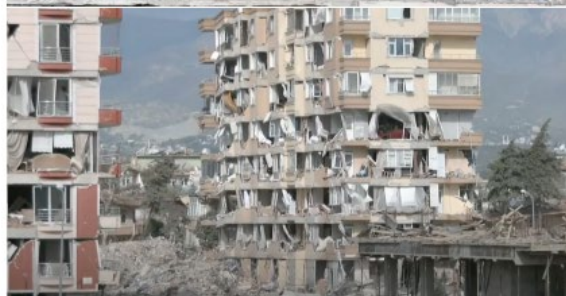
- One of the most important non-structural damage in the region was observed in the infill walls.
- The infill walls were severely damaged and failed under combined in and out of plane effects.
- The damage was similar in all the infill walls made of hollow clay brick, autoclaved aerated concrete or bims blocks, indicating that none of the block materials showed good seismic performance.

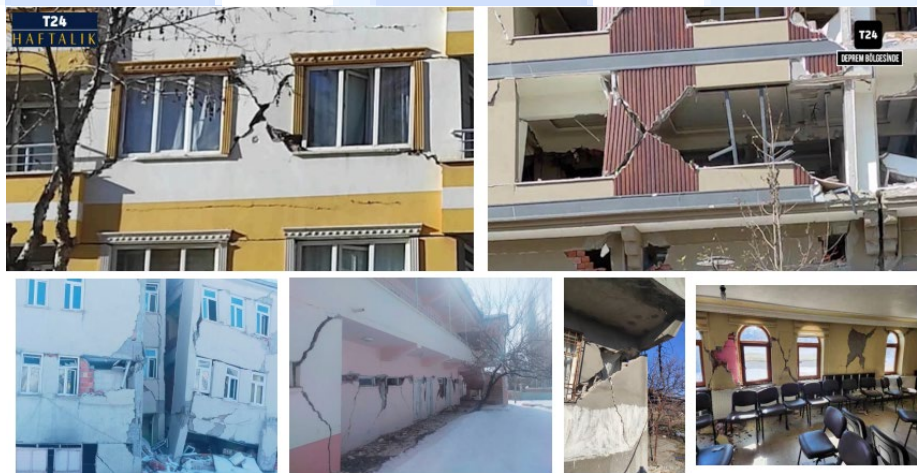
- Fallen panels from the ceiling and blocked corridor, indicating loss of functionality and giving evidence of the significant interior damage that can occur even if the exterior looks undamaged (EERI (2023))

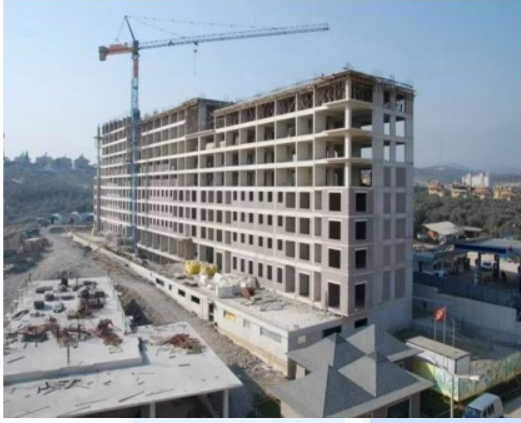
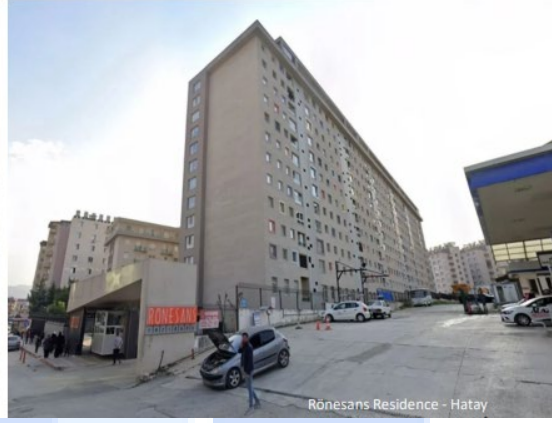
Ronesans Residence - Hatay

- Renaissance Residence was a residential building in Ekinci, Antakya, that fell over in February of 2023 during the first earthquake.
- The building is 12 floors high and has a total 249 homes, 2 shops. The building is divided into 4 blocks. The area that the building takes up on the ground is 10,500 square meters (113,000 sq ft).
- The building was built between 2011 and 2012.
- At least 800 people died.

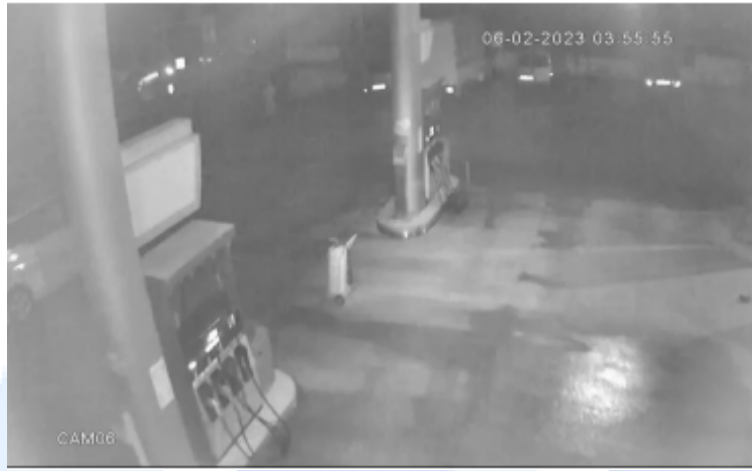
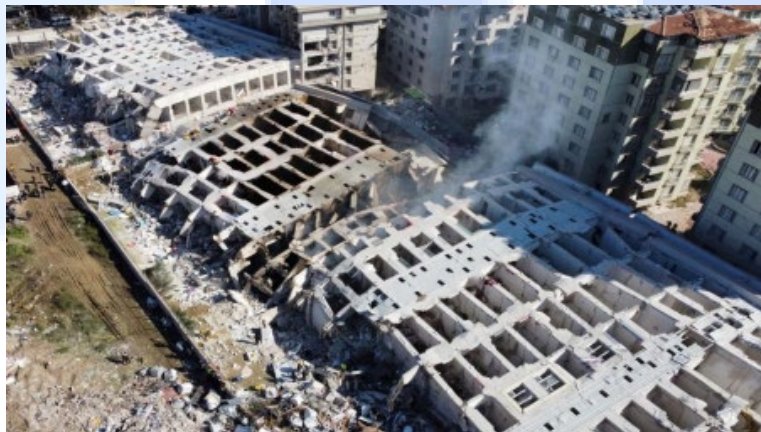
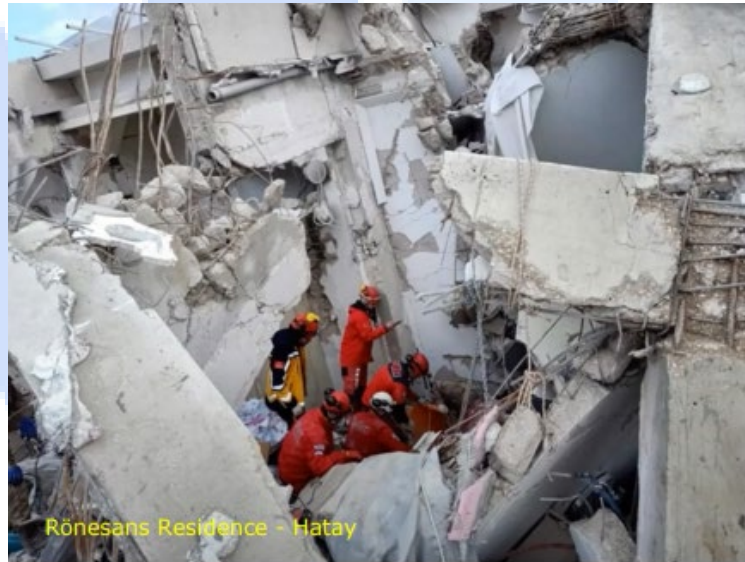
Rönesans Residence - Hatay

Potential reasons for this failure: (1) Inadequate foundation or, (2) Initiation of the collapse of the structure from one side (sidesway collapse), resulting in the toppling of the structure. The sidesway collapse occurs due to lateral dynamic instability at large lateral displacements, when the lateral strength of the structure degrades significantly (EERI (2023)).

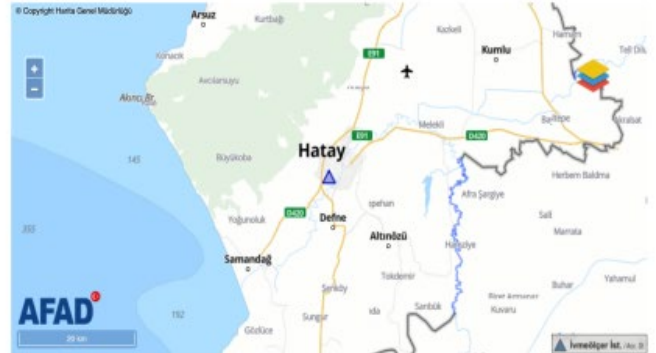
Waveform

Event ID	543428	Network	TK	Repl (km)	146.39
Event Date	06-02-2023	Station Code	3129	Rhyp (km)	146.64
	01:17:32	Latitude	36.19117	Rjb (km)	214.65
Latitude	37.288	Longitude	36.1343	Rrup (km)	214.65
Longitude	37.043	Elevation	106		
Depth	8.6 km	Housing	serbest alan		
MW	7.7	Type			
ML		Va30 (m/sn)	447		
MS		Ec8	B		
MB		(EuroCode)			
MB

Component	Sampling I. (s)	Butterworth Min (Hz)	Butterworth Max (Hz)	Arias Intensity (cm/s)	Housner Intensity (cm)	T90 (s)	Sa (0.3s) [cm/s <sup>2</sup> ]	Sa (1s) [cm/s <sup>2</sup> ]	Sa (3s) [cm/s <sup>2</sup> ]	PGA (cm/s <sup>2</sup> )	PGV (cm/s)	PGD (cm)	Raw Process	Automatic Process	Manual Process
E-W	0.01	0.1	25	1797.7304	318.4056	14.86	4240.27	739.31	232.31	1207.618	72.17	37.319	<input checked="" type="checkbox"/>	<input checked="" type="checkbox"/>	<input checked="" type="checkbox"/>
N-S	0.01	0.1	25	2466.3752	591.5778	10.71	4740.76	1906.45	279.09	1350.49	169.996	33.225	<input checked="" type="checkbox"/>	<input checked="" type="checkbox"/>	<input checked="" type="checkbox"/>
U-D	0.01	0.1	25	613.1711	173.4544	10.74	1196.86	240.72	205.17	707.554	43.381	19.226	<input checked="" type="checkbox"/>	<input checked="" type="checkbox"/>	<input checked="" type="checkbox"/>

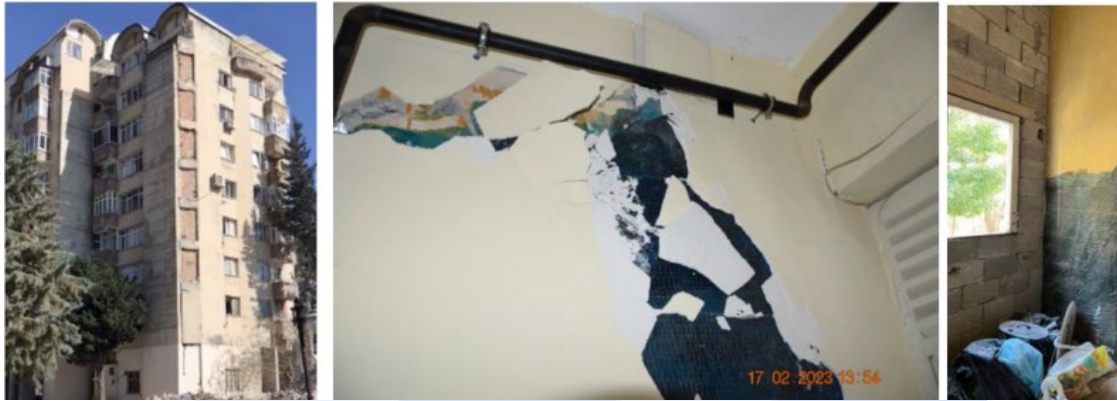
- The strengthened buildings with the addition of shear walls, fiber reinforced polymers collapsed while some damage was observed.

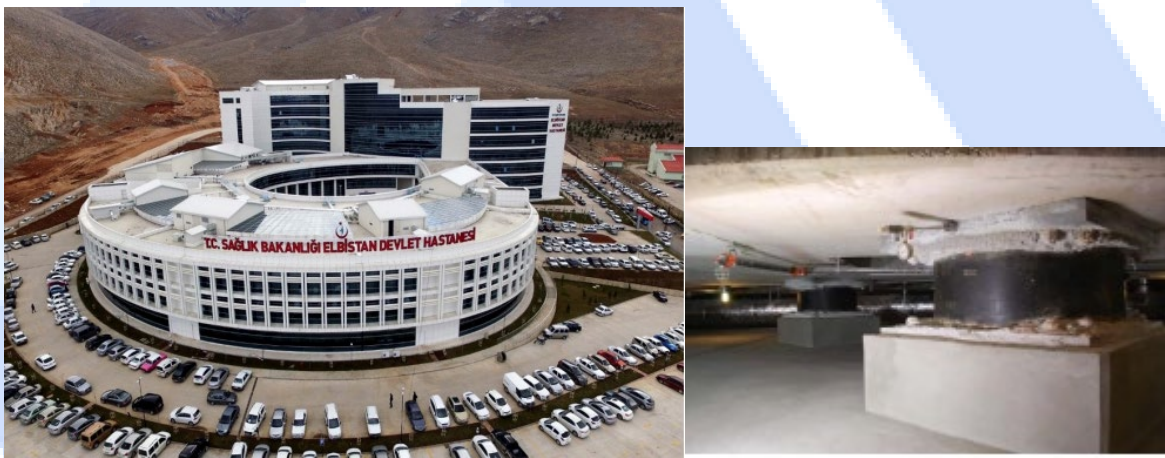
- All base-isolated hospitals were operational after the earthquake sequence.

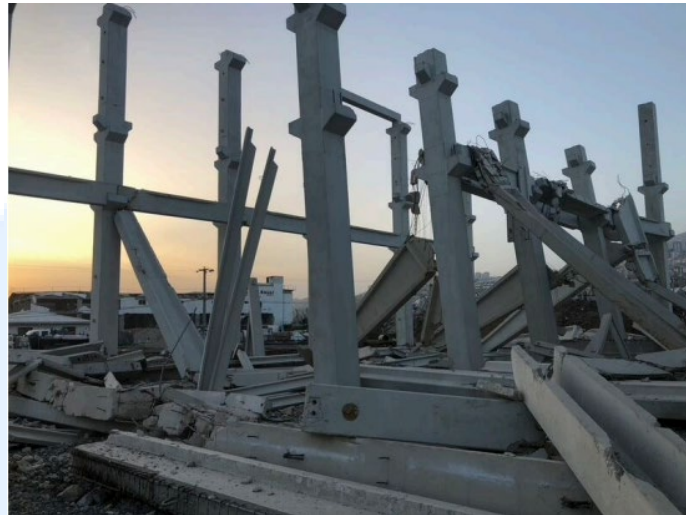
- Many older prefabricated buildings have experienced significant damages or some partially or totally collapsed from many reasons: mainly from weak connection and detailing, insufficient diaphragm effect.

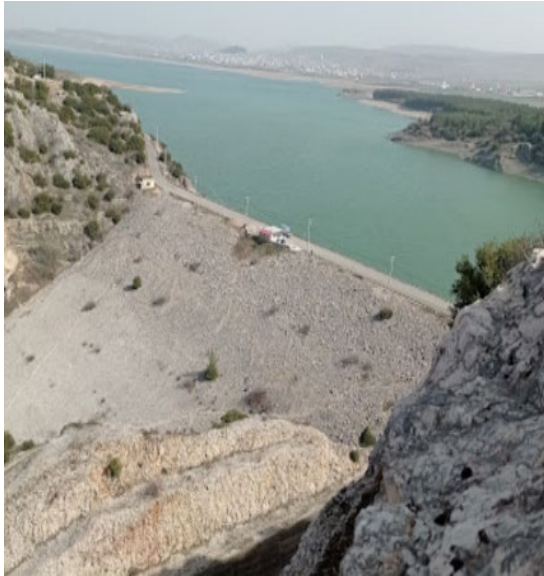
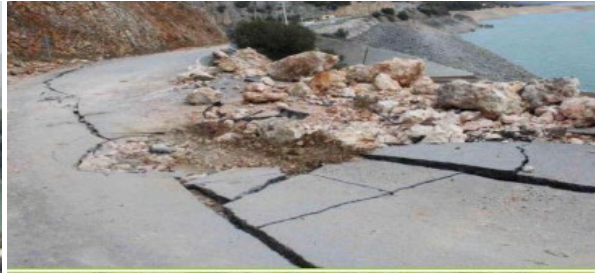
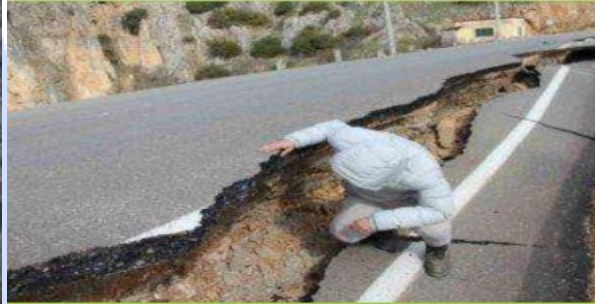
- Kartalkaya Dam with height of 57m is a rock fill dam constructed in 1972 in Pazarcik-Kahramanmaraş.
- Distance from the Mw7.7 epicenters is 38km.
- Serious cracks occurred along the dam crest.

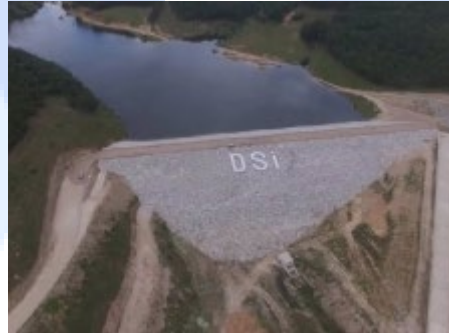
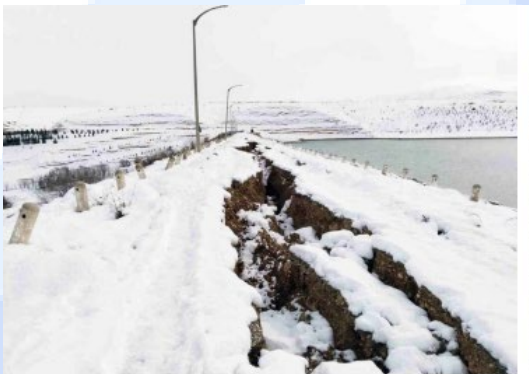
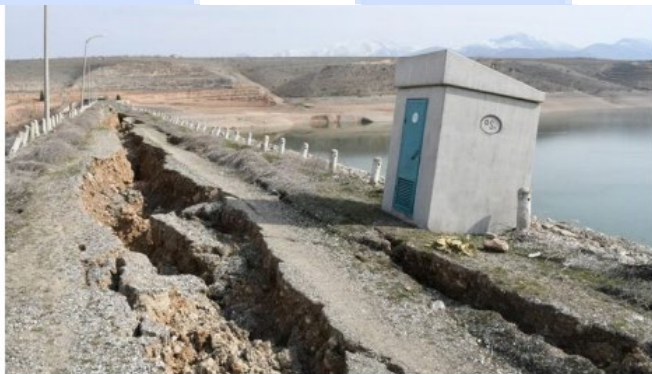
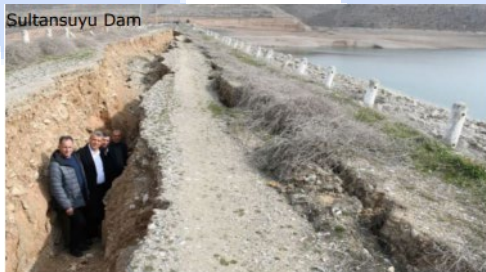
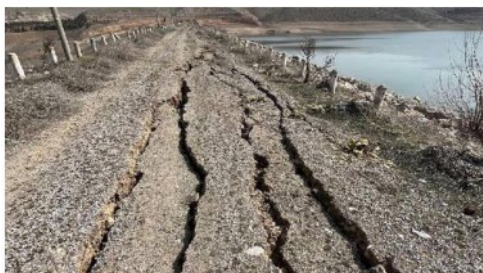
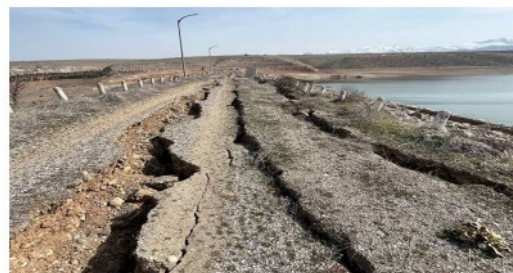
- Sultansuyu Dam is a embankment dam constructed in Malatya in 1992. The height 60 m (from talveg) and crest length 721m.
- Distance from M7.7 from 156km, from M7.6 70km.

- It is 8.8 km away from Malatya Fault Zone- Akçadağ segment. There is no other dam under the influence of near source (closer than 10 km to the active fault zone).
- Serious cracks occurred along the crest and upstream face of the dam
- The reservoir was discharged after the earthquake.

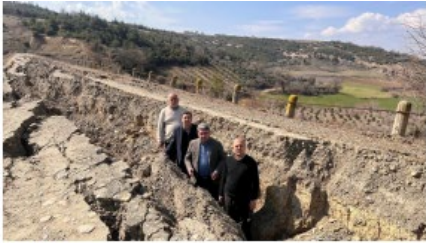
- Arıklıkış pond with height of 33m is a rock fill dam constructed in 1998 in Bahçe-Osmaniye.
- Serious cracks occurred along the dam crest and upstream face.

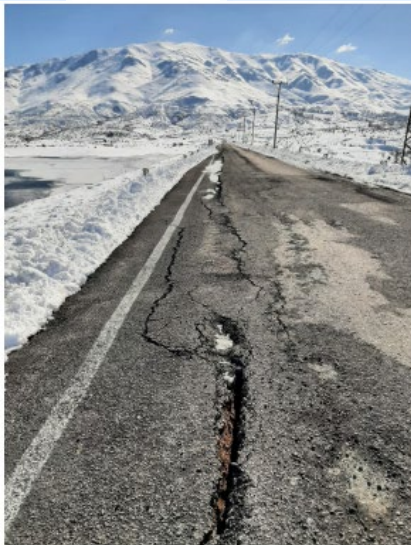
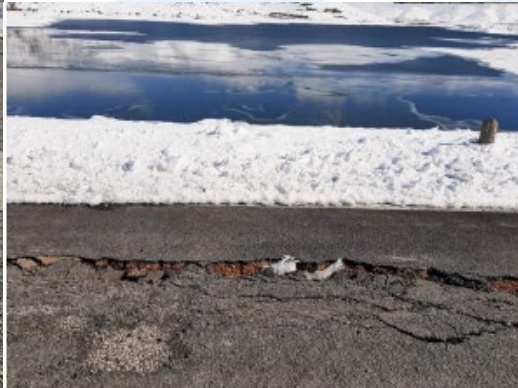
- Malatya Sürgü Dam with height of 55m is an embankment dam constructed in 1969 in Malatya.
- Cracks occurred along the dam crest due to Mw 7.6.

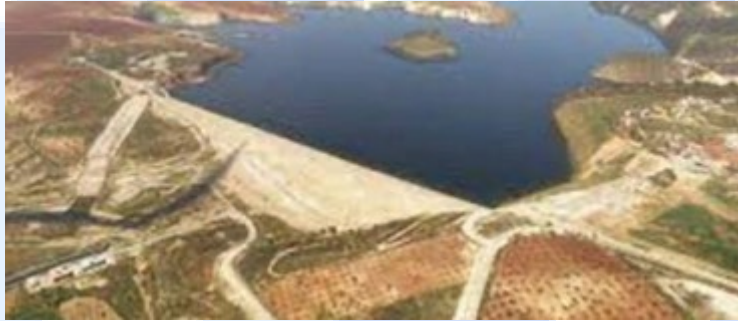
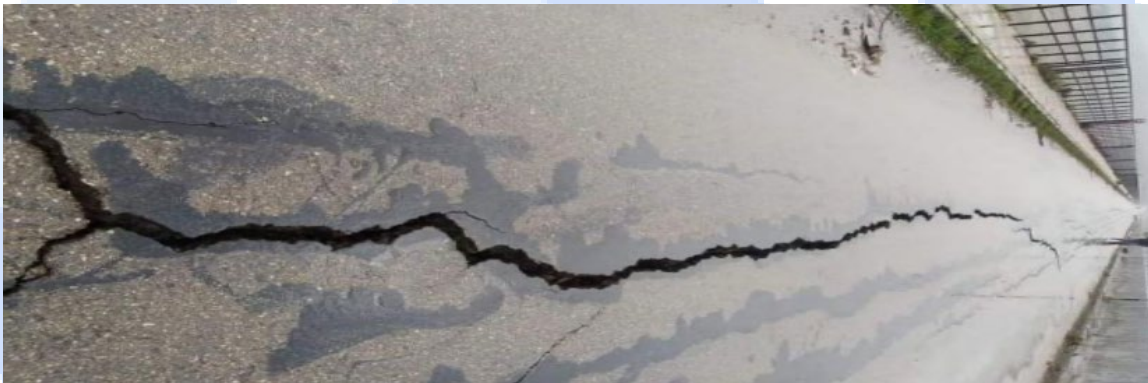
- Maydanki (Afrin) Dam (in Syria) is an embankment dam, and it is 73 m high, with a crest length of 983 m.
- It is located near the south-west border of Turkey.
- Serious cracks occurred along the crest of the dam.
- It was reported that the reservoir has been emptied after the earthquake.
