# PACE-2023

The Second International Congress on the  
Phenomenological Aspects of Civil Engineering

Transactions  
of  
The Second  
International Congress  
on the  
Phenomenological Aspects  
of  
Civil Engineering

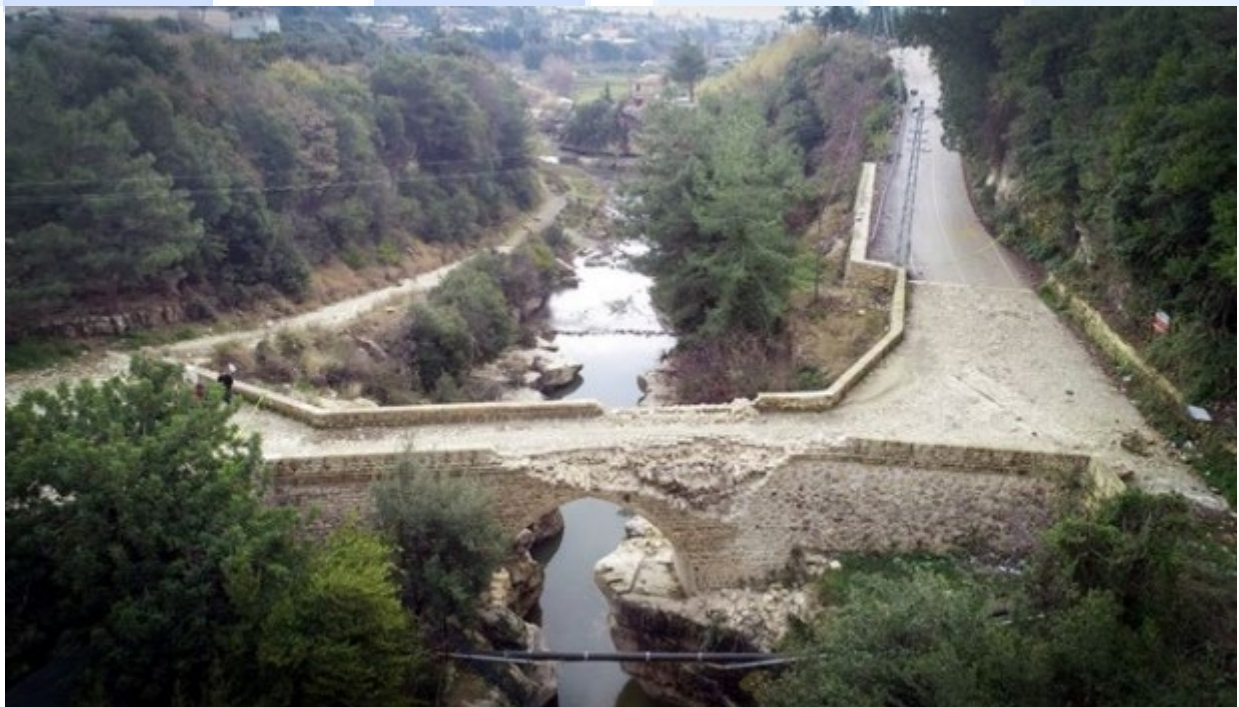
- About 1,000 bridges in the earthquake-affected region (SSB, 2023).
- A bridge collapsed due to rockfalls

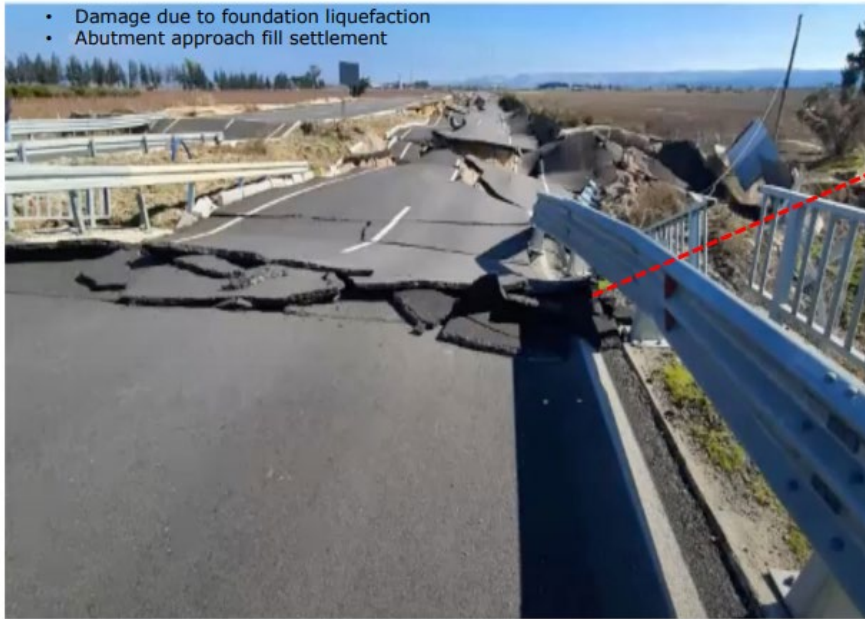
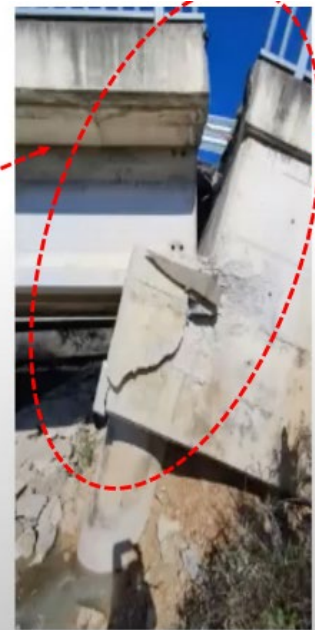
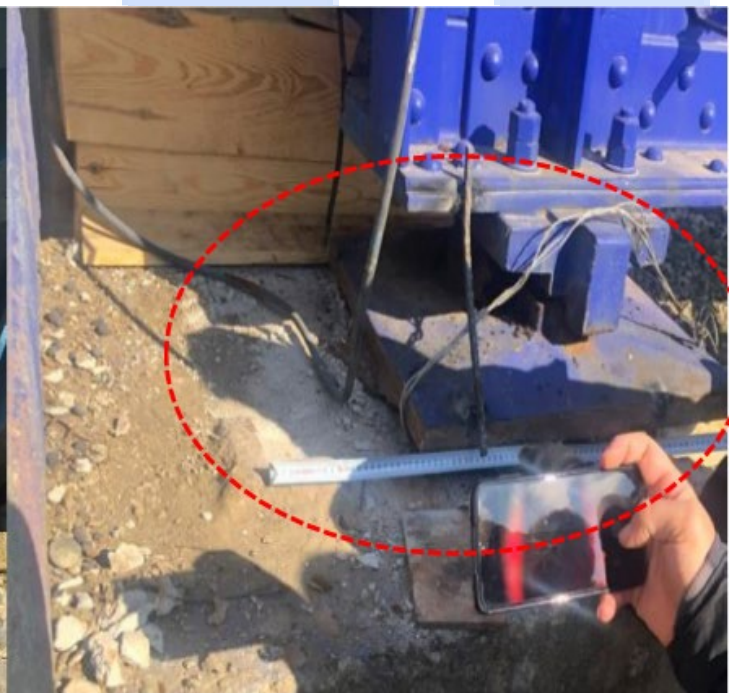
## Batiayaz Köprüsü

- Expansion joint movements

- Damper damage at expansion joint

- Bridge column (diamater 3m) damage (plastic hinge, spalling of cover concrete, buckled vertical rebar and yielded transverse rebars)

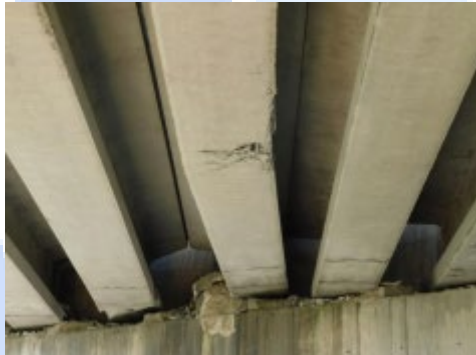
- Damage to end of bridge precast girder

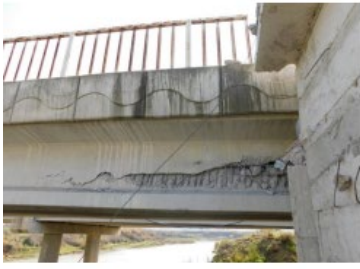
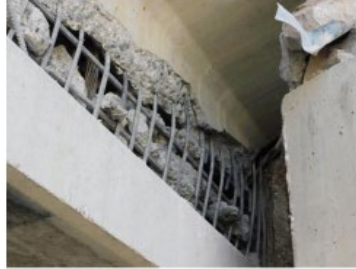
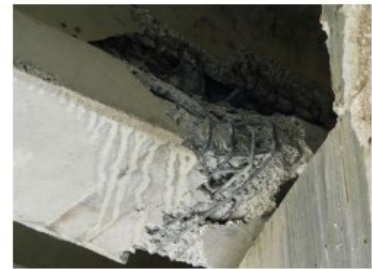
- Exterior and interior shear key failure

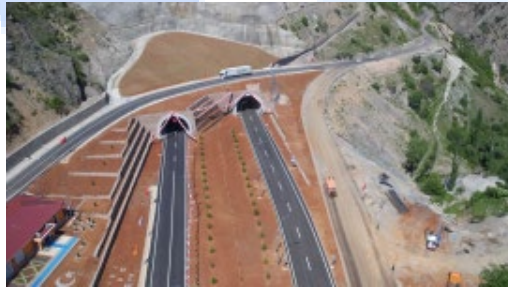
- Erkenek Tunnel is a twin-tube tunnel with a length of 1,816 m.

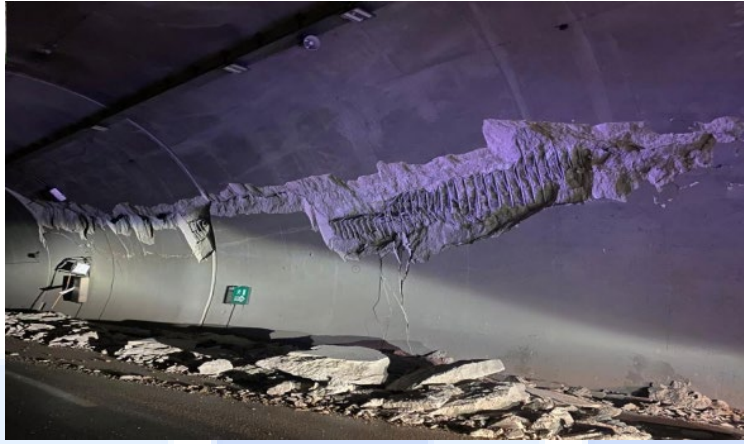
- RC tunnel structures in general performed well during and after the event.
- No serious damages were observed in the highway tunnels.
- Some concrete spalling, and minor portal damages were observed.

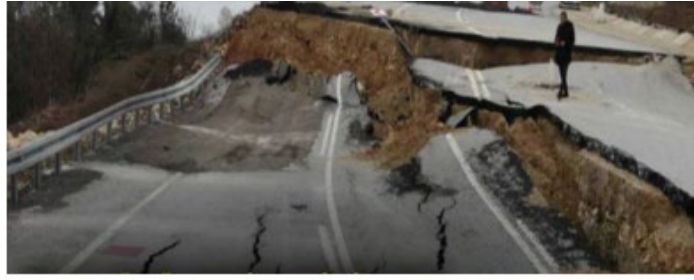
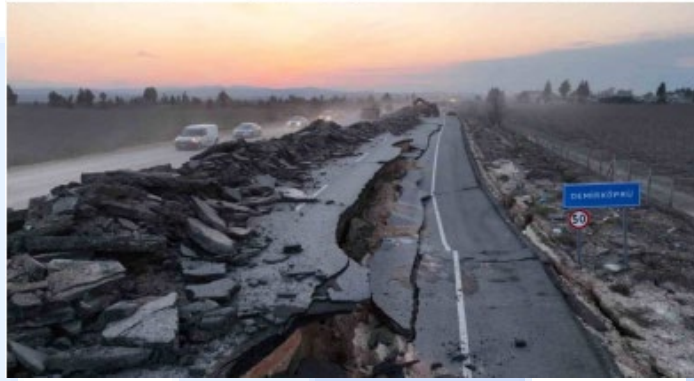
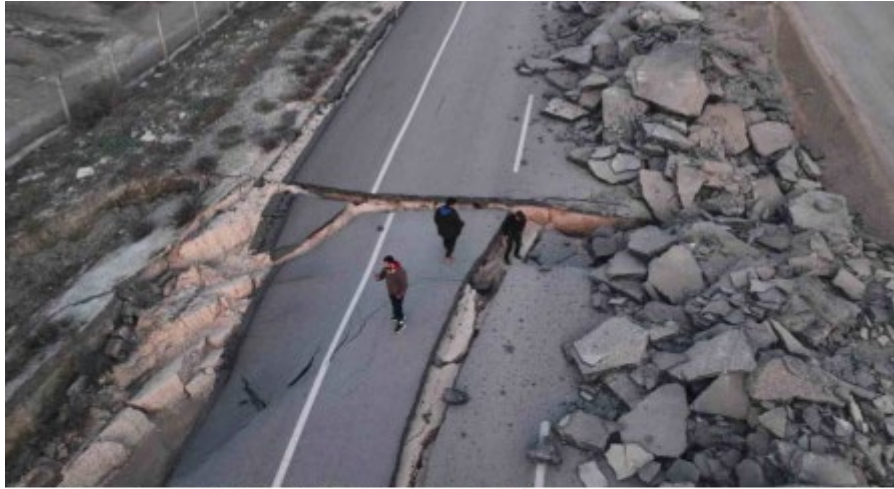
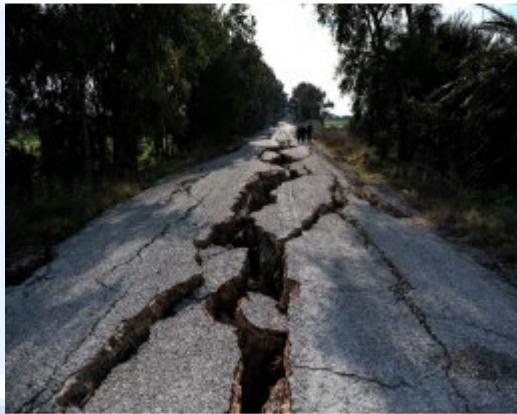
- 15 percent of the existing highway network in Turkey, 12 percent of the state road network, and 14 percent of the provincial road network are located in the earthquake-affected provinces.
- Surface fault rupture-induced serious deformations, offset, buckling, uplift and subsidence on asphalt roads, highways, railway tracks as well as on unpaved roads and farmlands.

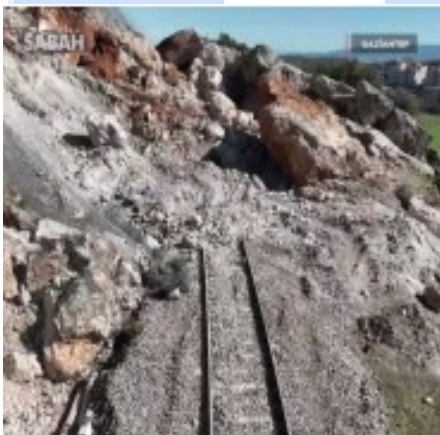
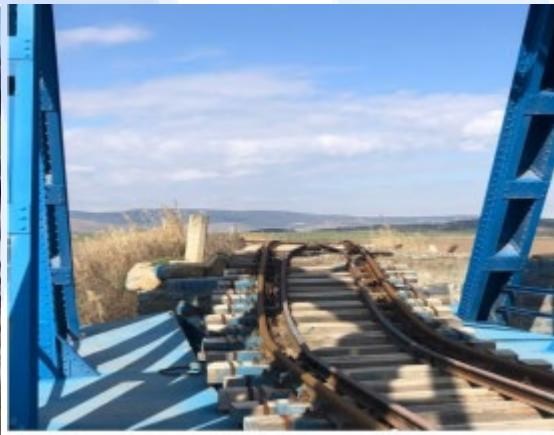
- The total length of the railway in the disaster zone is 1,275 km.
- The railway network's Mersin-Adana-Osmaniye-Narlı, ToprakkaleIskenderun, Fevzipaşa-Islahiye, Köprüağzı-Kahramanmaraş, NizipGaziantep-Narlı, Narlı-Malatya, Çetinkaya-Malatya, Malatya-Elazığ, and Malatya-Yolçatı-Diyarbakır sections have also been affected by the earthquakes.
- Generally, there have been collapses in tunnels, line deformations, landslides, rockfalls, and structural damage to bridges on the lines.

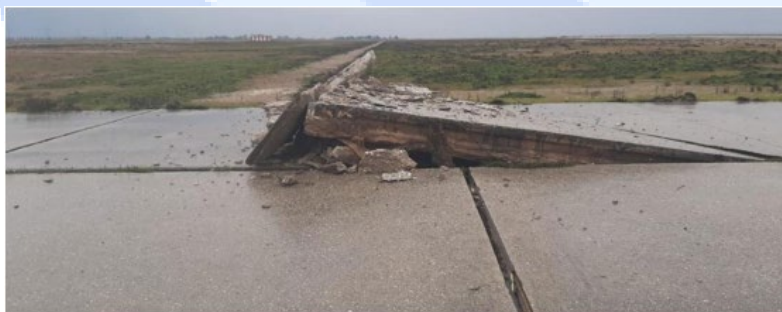
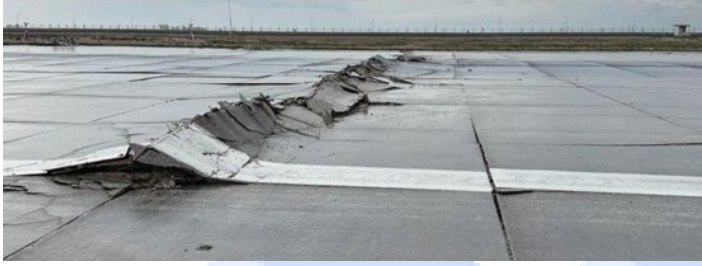
### 3.14. Performance of Airport Runway

- Hatay airport experienced some damage to its runway due to soil and foundation problems and was closed to air traffic in the first three days after the earthquakes.

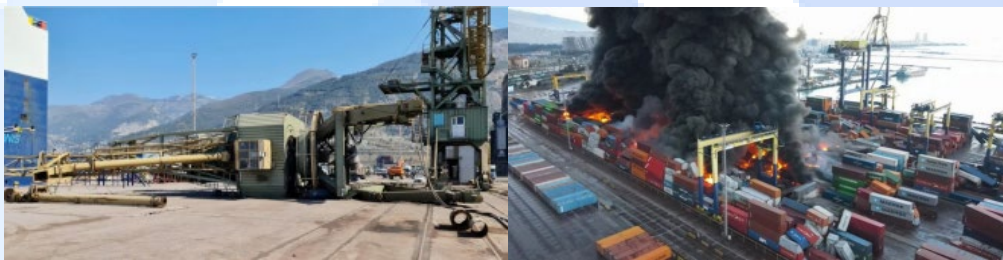
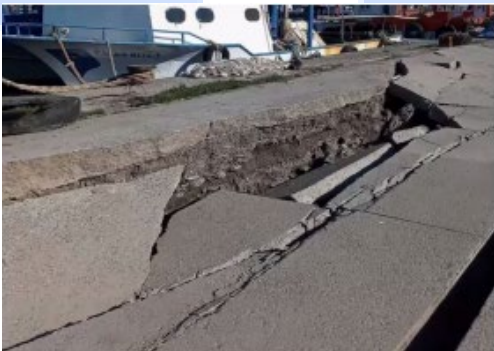
### 3.15. Performance of Ports

- There are 13 ports operated by the private sector in the Iskenderun Gulf (SSB (2023)).
- Serious damages and a big fire occurred in Iskenderun port.

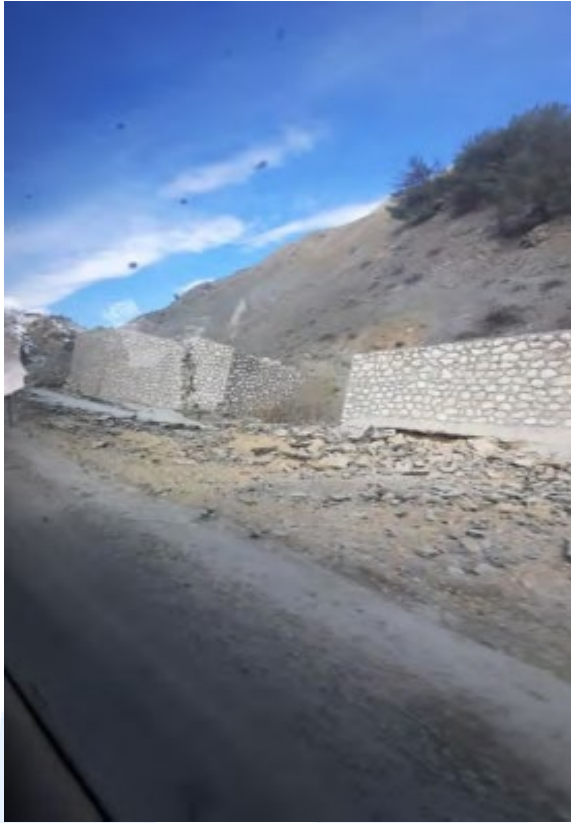
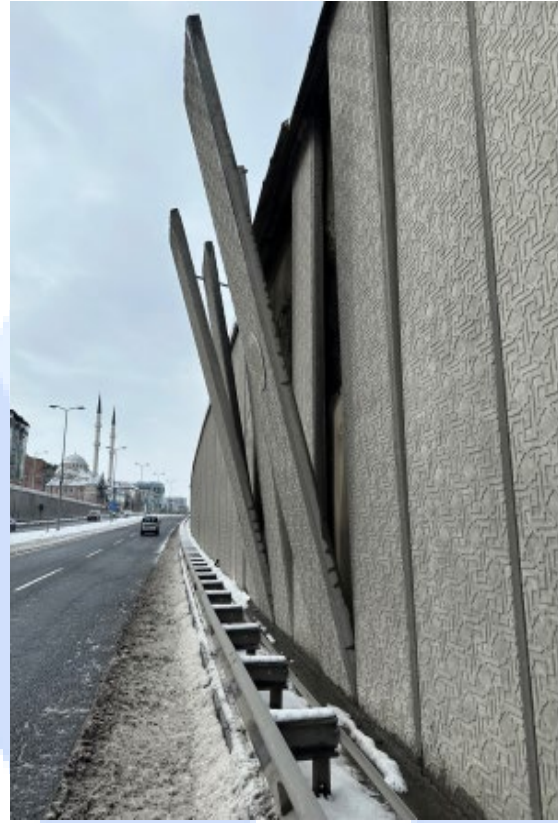
### 3.16. Performance of Retaining Walls

- Cracks, tilt, lateral displacement and damages on retaining walls were observed

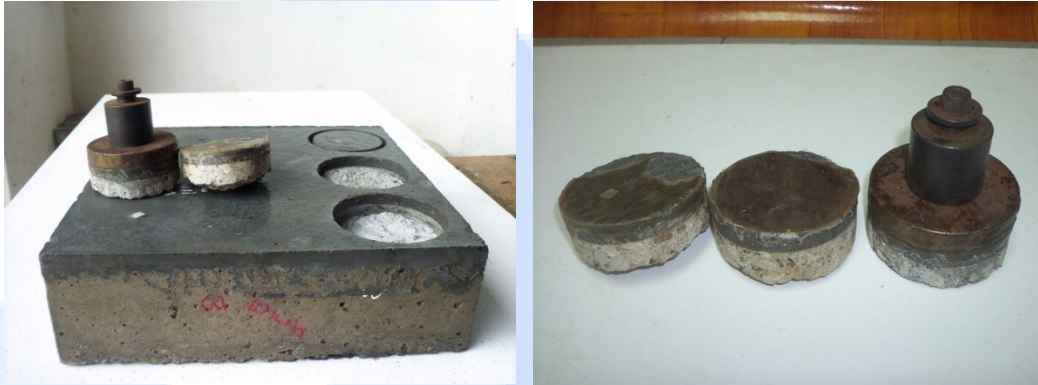
Figure 19. (a) Pull off test set-up for the composite specimen, (b) Failure through the NC substrate

The results of pull-off test showed that in all specimens and at all ages of the test, the failure occurred in the NC substrate, indicating a strong bond with the UHPFC.

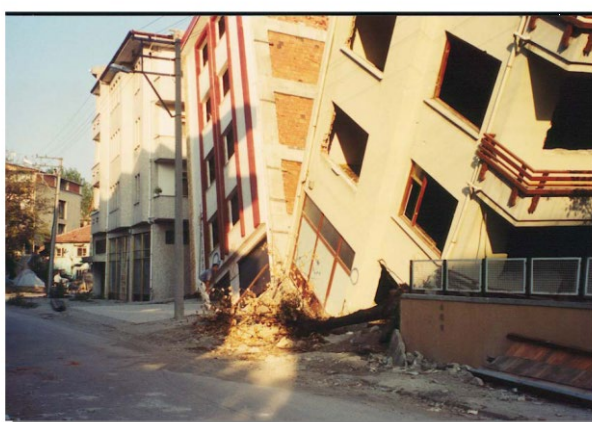
Figure 7. Liquefaction Damage, Adapazari, Turkey, 1999

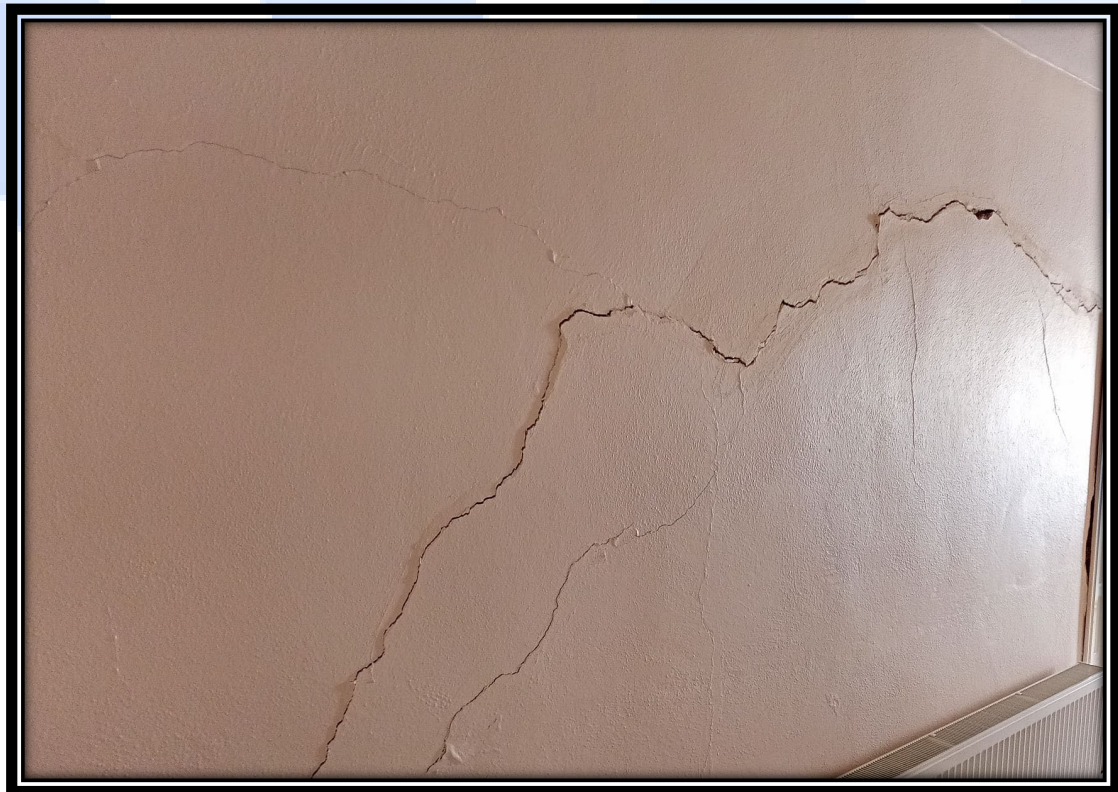
Figure 11. An example of the damage observed after the April 13, 2023 Aziziye Earthquakes

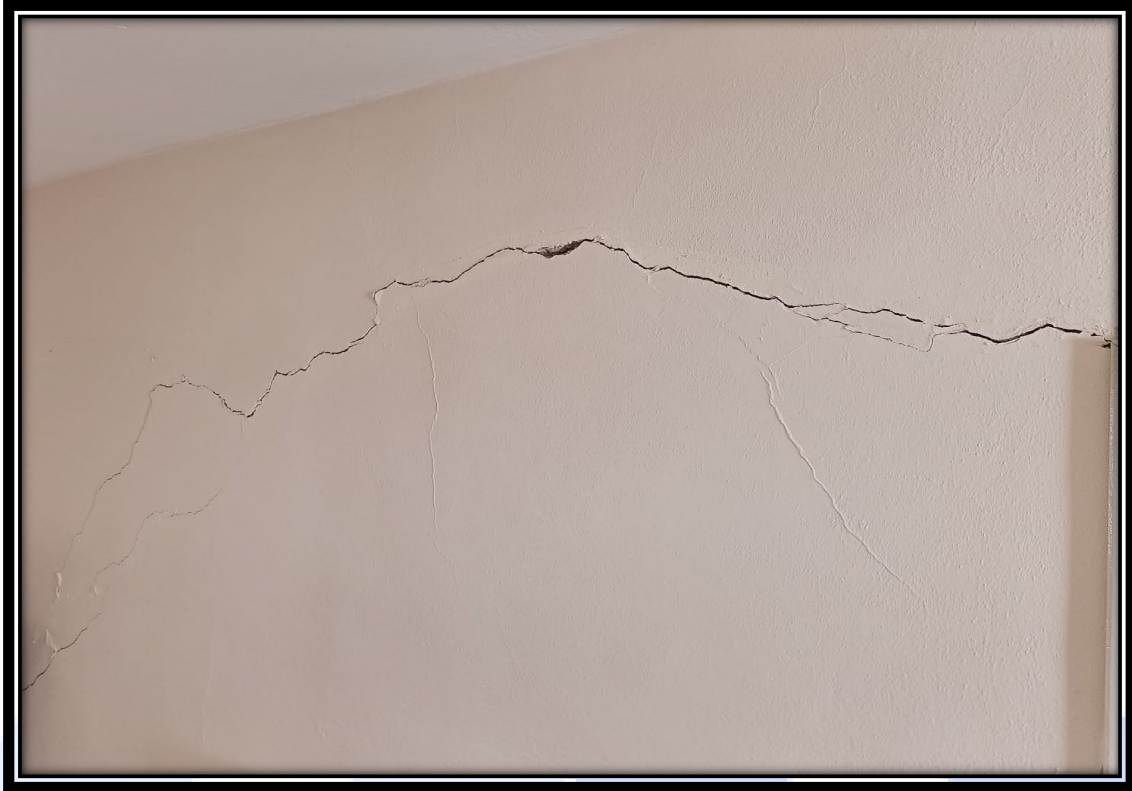
Figure 12. An example of the damage observed after the April 13, 2023 Aziziye Earthquakes

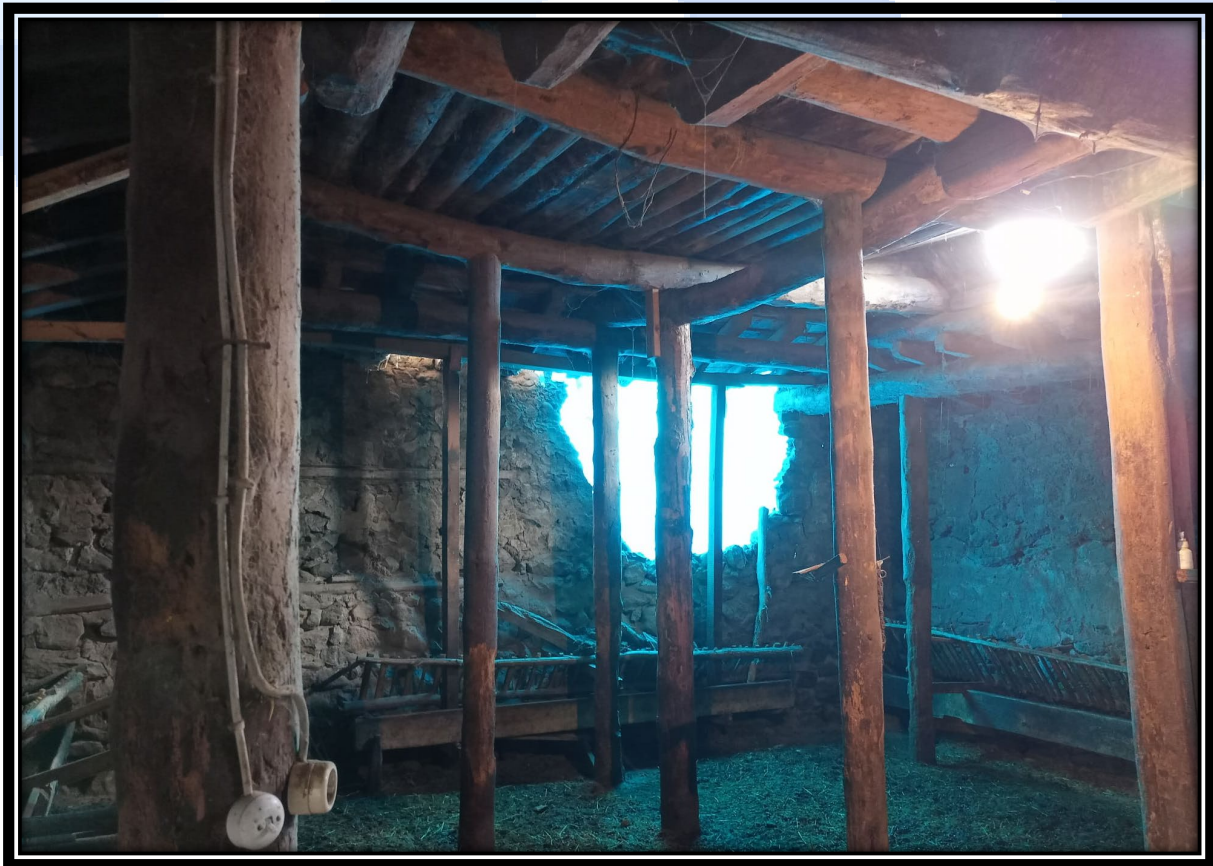
Figure 13. An example of the damage observed after the April 13, 2023 Aziziye Earthquakes

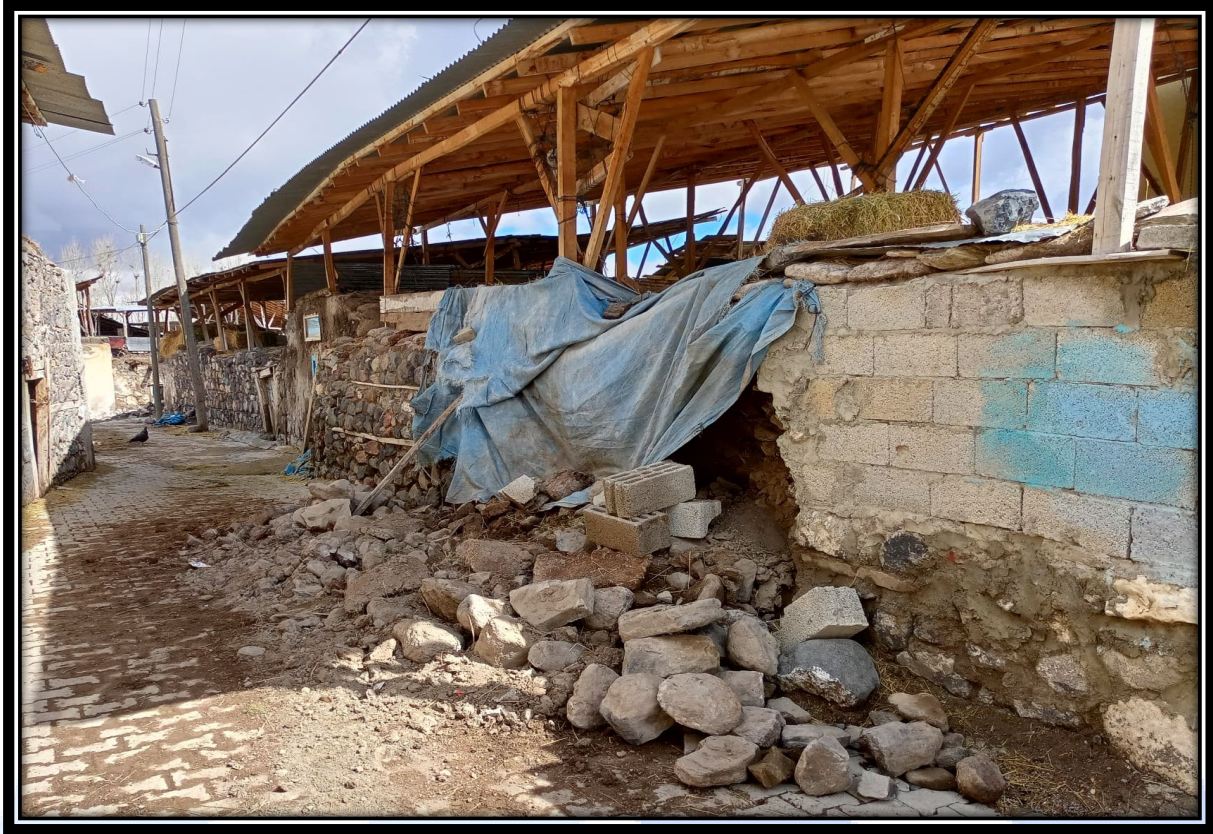
Figure 14. An example of the damage observed after the April 13, 2023 Aziziye Earthquakes

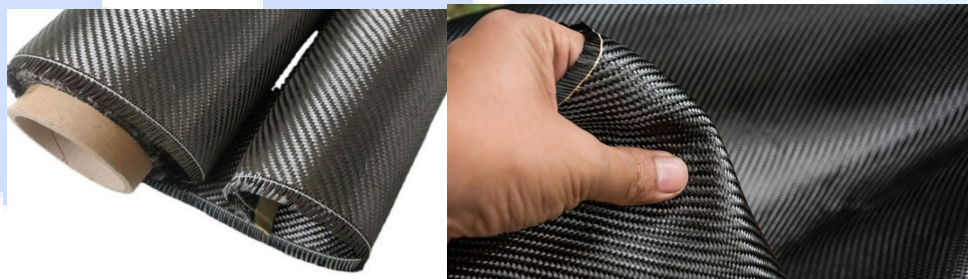
Figure 1. Carbon fiber sheets

### 2.2.2 Carbon Fiber Sheets (See Fig. 1.)

Fiber Reinforced Polymer is an attractive material for structural engineers because it has high tensile strength and is lightweight, corrosion-resistant, non-magnetic, and not sensitive to electricity. It has a higher strength-to-weight ratio, stiffness-to-weight ratio, and lower life cycle costs than steel, but its initial cost is higher. However, FRP has some drawbacks, including its weakness in the transverse direction and lack of ductility, which leads to non-preferred performance for concrete elements reinforced or prestressed with FRP rods. FRP is also more expensive than steel. The stress-strain relationship for steel and different types of FRP are presented as shown in Fig. 2. and listed in Table 2. (Saeed, 2016)

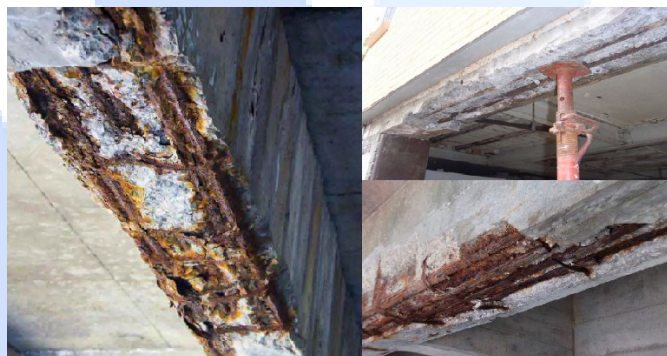
Figure 5. Corrosion in the middle lower part of the concrete beam

To begin with, we started modeling the concrete beam. It had dimensions of 300 mm by 600 mm and a length of 4000 mm. We used steel bars that were 16 mm in diameter and strips that were 8 mm in diameter. The spacing between the strips was different depending on whether it was in the middle or on the sides of the beam. On the sides, the spacing was approximately 150 mm, while in the middle part, it was around 250 mm. The middle part, with a width of 2000 mm, was the specific area we focused on because it was considered to be the part most affected by corrosion. Table 4 shows the steel bars strips and the effect of corrosion on them.

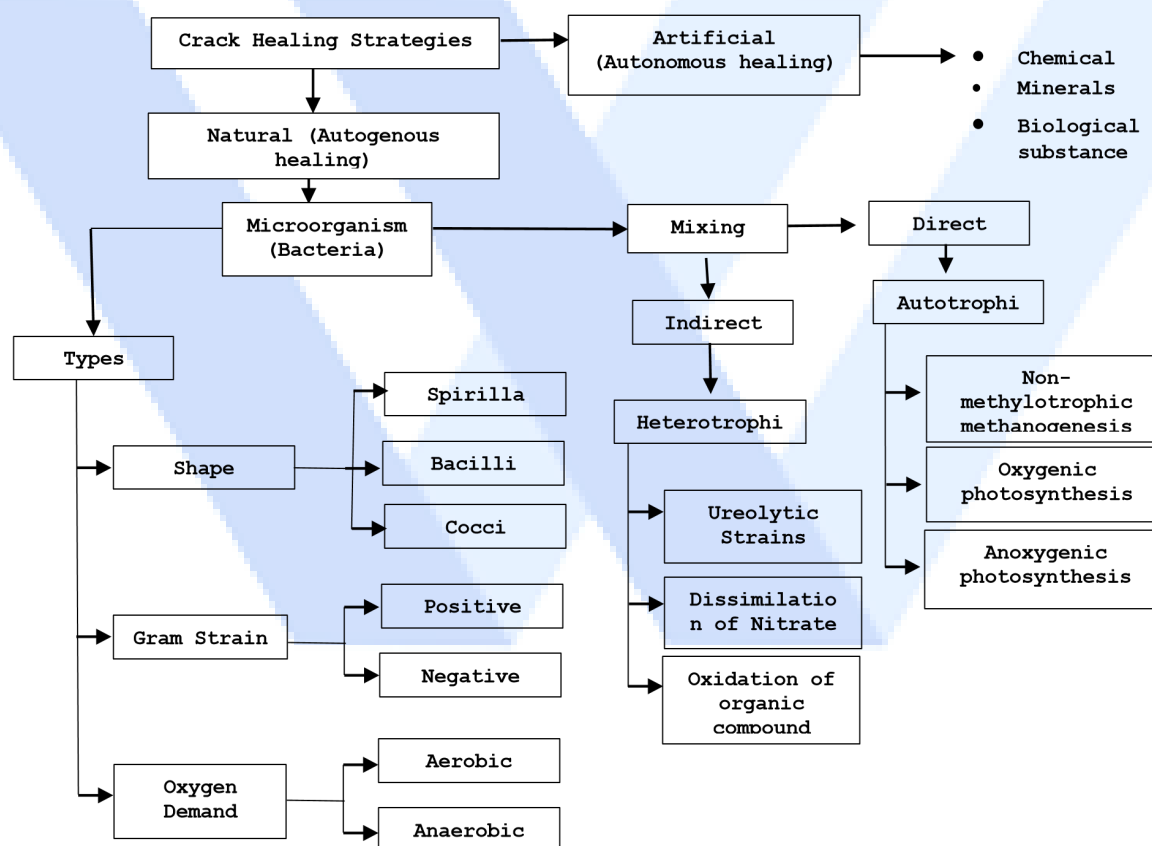
Figure 1. Crack healing strategies as depicted from [10, 11, 13,18]

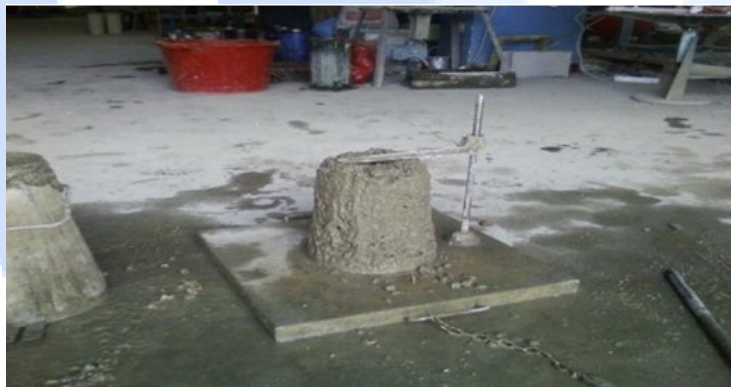
### Abstract

Is evaluated using the Abrams cone, in accordance with standard NF P 18-451 [9]. The test consists of introducing the fresh concrete into a frustoconical mold (D=20, d=10, H=30 cm) in three layers, where each undergoes 25 tapping strokes using a Q16 mm rod, then the mold is slowly removed and the sag measurement taken.

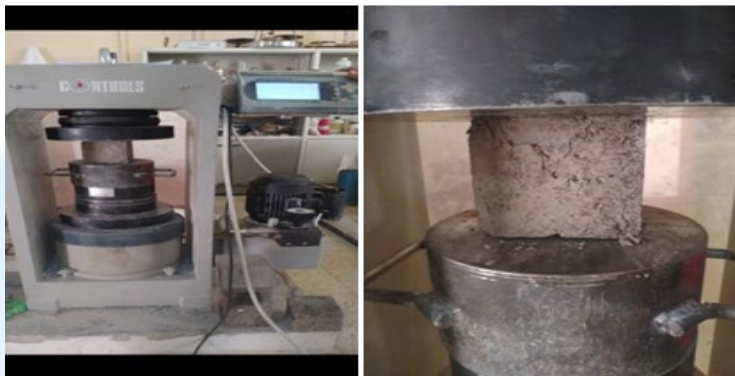
Figure 8. Compressive testing machine

The test for determining the compressive strength of the specimens is carried out in accordance with the requirements of the NA 427 standard [10]. The breaking stress is given directly by the testing machine (Figure 8.)

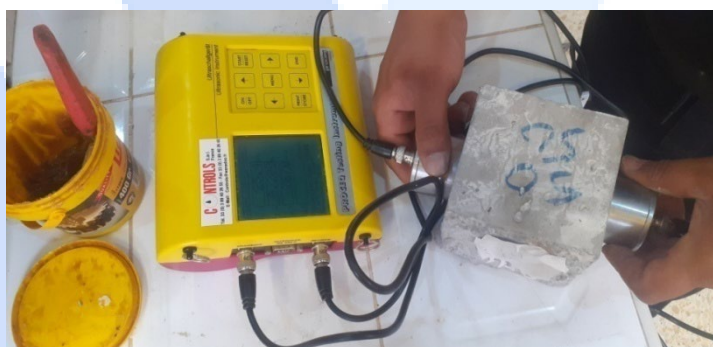
Figure 9. Calibrating the Ultrasound device

Ultrasound monitoring is a non-destructive method intended to test the homogeneity of concrete, it consists of determining the speed of propagation of longitudinal (compression) waves through a concrete element in accordance with standard NF P 18-418 [11]. The principle of the method consists in measuring the time taken by a wave to travel a given distance. The relationship between the speed of propagation of ultrasonic waves and the compressive strength is affected by a number of variables such as the age of the concrete, the humidity conditions, the ratio between aggregates and cement, the type of aggregates and location of steels and cracks. Ultrasonic inspection makes it possible, without harming the integrity of a structure, to characterize the defects it contains and thus to pass judgment on the acceptance of the parts produced.

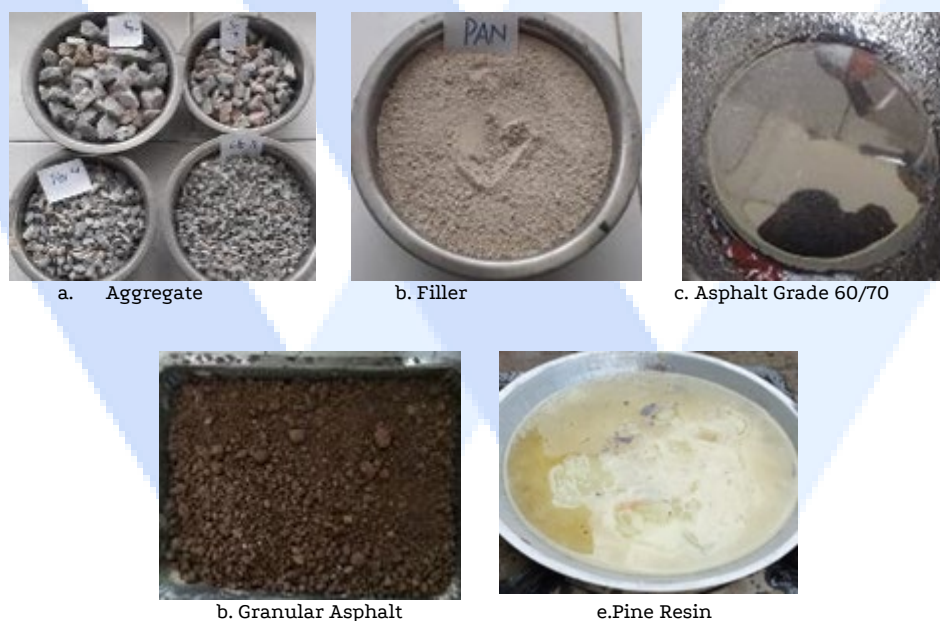
Figure 1. Materials used to make specimens of hot mix asphalt AC-WC

Materials used to make the specimens of hot mix asphalt AC-WC consist of aggregate, asphalt pen 60/70, Buton natural asphalt grade B 50/30, and pine resin.

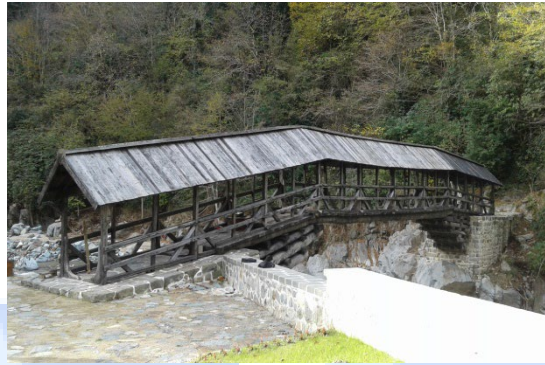
Figure 1. The Buzlupınar Bridge

Buzlupınar Bridge was built on the Madenli stream located in the Çayeli province of Rize city in northern Turkey. This bridge utilized for regional pedestrian, animal, and cargo transportations, is completely made of timber using rare construction techniques. The total bridge length and width are approximately 31.50m and 2.20m. The main span length between both abutments is 21.80m. It is formed the several structural elements. The main carrier system consists of simply supported three timber main beams of circular cross-section and timber studs with various rectangular cross-section areas from 90cm<sup>2</sup> to 238cm<sup>2</sup>. Before the restoration process, the spans and diameters of main beams varied between 14.35m to 14.50m and 21.00cm to 25.00cm, respectively. The diameters of the main beams changed to 40cm, after the restoration process. The timber studs are connected and the deck of the bridge utilizing timber beams and L-shaped buttress. Other timber structural elements of the bridge are transverse bracings, deck plates, railings, and roof elements (purlins, rafters, etc.). Moreover, the main span of the bridge reduces by cantilever beams fixed to both abutments. Abutments have a total of 39 cantilever beams stabilized by perpendicular beams. The lengths, diameters, and horizontal angles of cantilever beams vary between 5.35m to 9.87m, 16.00cm to 32.00cm, and 5° and 20°, respectively. Fig. 1 presents some photographs of the general view of the bridge. The structural schemes in the plan views of the restoration project are given in Fig. 2

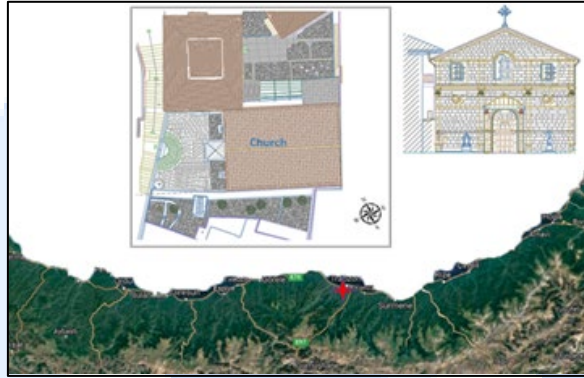
Figure 1. The location and plan view of the Santa Maria Church

Santa Maria Church is a unique historical structure located in Trabzon, Turkey. The church building is one of the important historical structure of the Trabzon province, and it is still in use. It is known that it was built between 1869 and 1874 according to historical records. Fig. 1 depicts location and plan view of the church building.

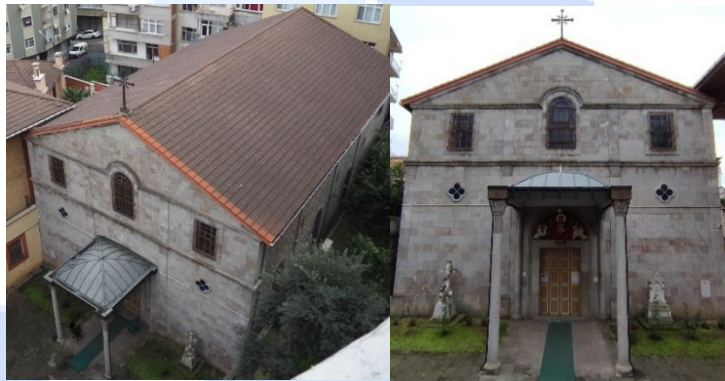
Figure 2. Views of the church building

The church building was constructed of stone masonry. The structure is 14x20m in size and has a square plan. The building's height is approximately 12.4m. Vaults and arches were used to cover the roof of the church, which features a wide courtyard. Fig. 2 shows views of the church building.

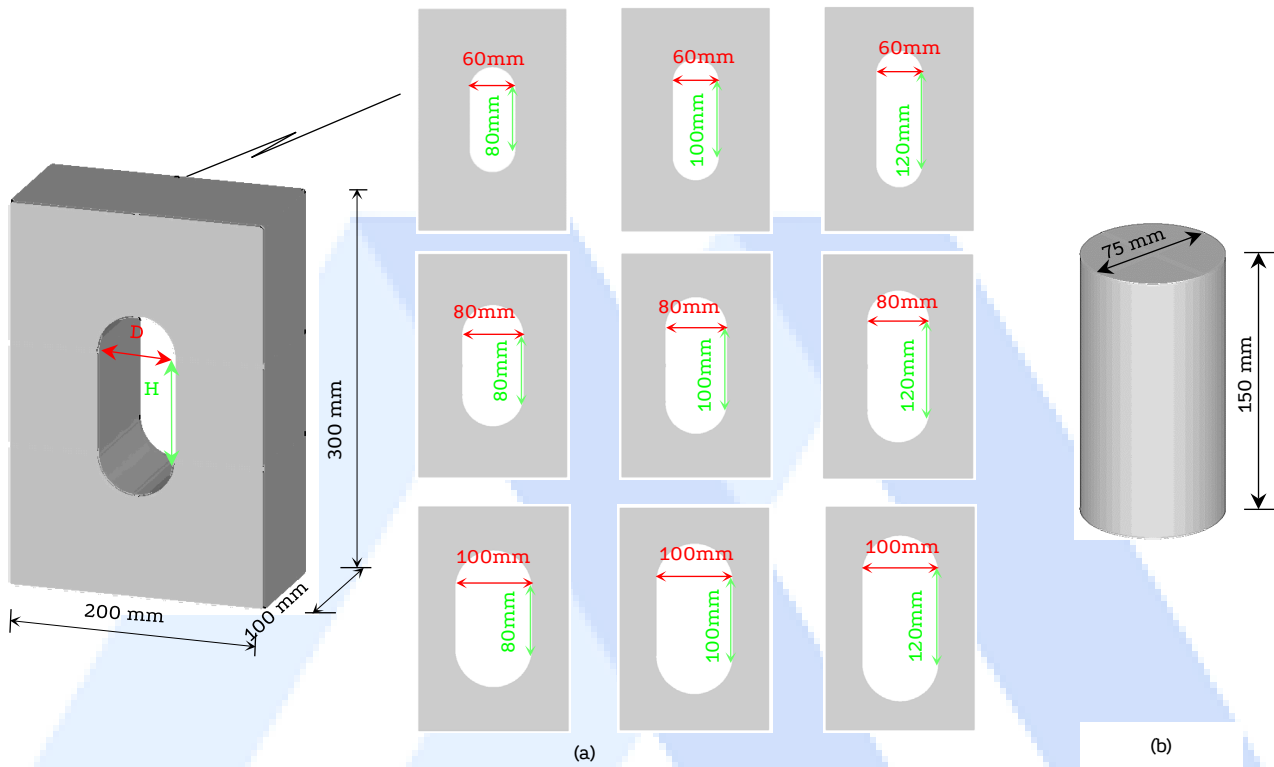
Figure 3. Considered dimensions of the (a) proposed HBT specimen and DTT specimen
